Chihuahua Operations

Performance Review

BWIGroup Suspension Systems QRD Review

Presented 5/28/2019 GART Data through 4/30/2019

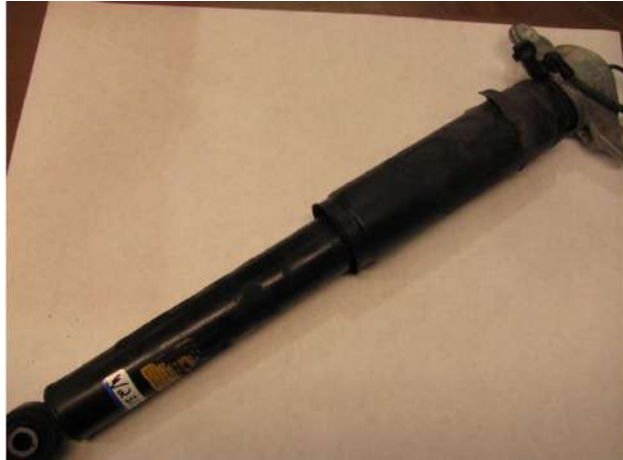
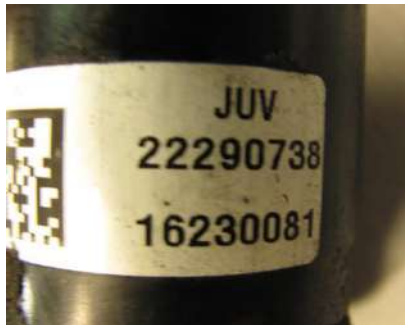
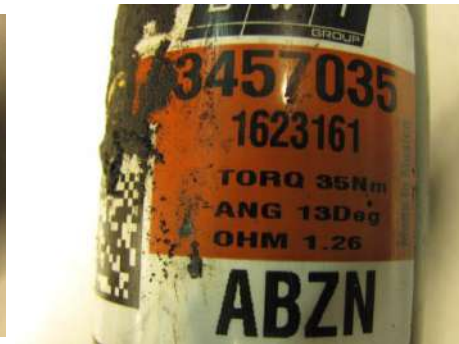
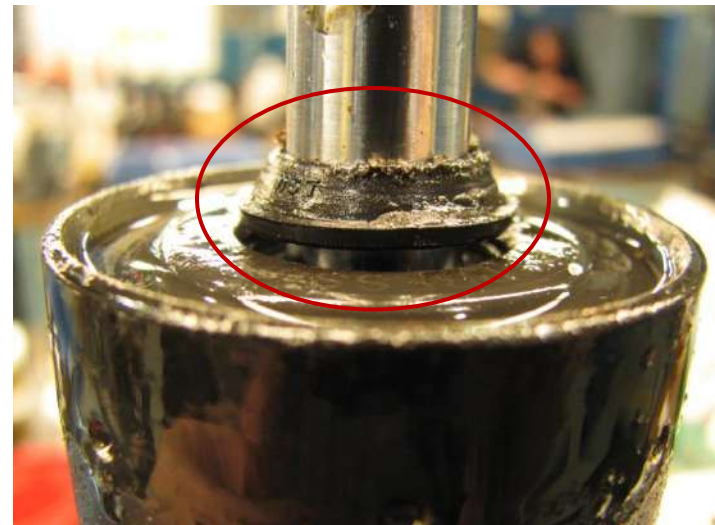
- Damper build date: 8/17/2016
- Model: 2017 XTS Rear
- VIN: 2G61M5S34H9112575
- Mileage: 43,186
- State: CA
- Cause: Leakage

- Leakage on cover assembly
- Wiper seal dislodged from cover assembly

NG

- Resistance: 1.23 - **OK**
 - Spec: 1.28 ± 0.2 Ohms
- Preload: 213 - **NG**
 - Spec: 432 ± 40 N
- Stickout: 83 - **NG**
 - Spec: 33.0 ± 3.0 mm
- Piston rod surface finish measurement:
 - Spec: .04 Ra Max
 - Measured: .0175 to .0481 Ra **NG**

- Deep scratches and comets on rod **NG**
- Twisted O-Ring **NG**
- Rust in bearing

- Twisted O-Ring allowed for gas and fluid leakage to occur.
- Dislodged wiper seal allowed for contamination on the rod, scratching it when stroking.

- Gen 2.5 Rod guide assembly put into production 1/12/2018
- Twisted O-ring, Addressed in Q1-2017 with addition of conical installation fixture. No reoccurrence.

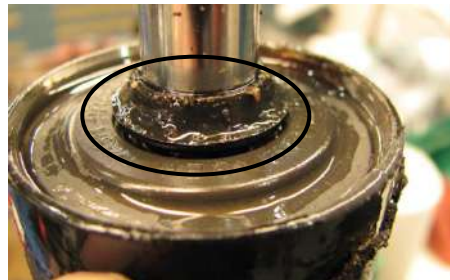
- Damper build date:
 - W2314A: 1/10/2017
 - W2314B: 1/12/2017
- Model: 2017 XTS Rear
- VIN: 2G61M5S35H9162210
- Mileage: 46,839
- State: WI
- Cause: Leakage

- Leakage noted on dampers (clear fluid not MR fluid)
 - Wiper seal dislodged from cover assembly
- NG**

W2314A wiper seal
NG

- Resistance: 1.26 - **OK**
 - Spec: 1.28 ± 0.2 Ohms
- Preload: 272 - **NG**
 - Spec: 432 ± 40 N
- Stickout: 53 - **NG**
 - Spec: 33.0 ± 3.0 mm
- Piston rod surface finish measurement: **NG**
 - Spec: 0.040 Ra Max
 - Measured: .0227 to .0444 Ra **NG**

- Scratches and some comets on rod **NG**
- Rust accumulation on bearing and damaged primary seal
- Rod surface finish does not meet spec **NG**

- Dislodged wiper seal allowed for contamination to come in contact with the rod, scratching and damaging the rod. The damaged rod compromised the seal and allowed fluid and gas leakage

- Gen 2.5 Rod guide assembly put into production 1/12/2018
- Implemented 100 grit rough grind wheel, and improved machining parameters 3/23/2018

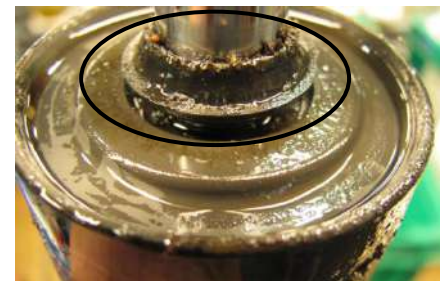
W2314B wiper seal
NG

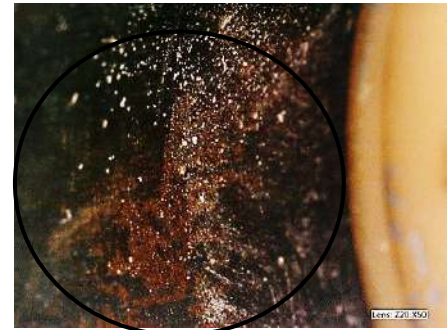
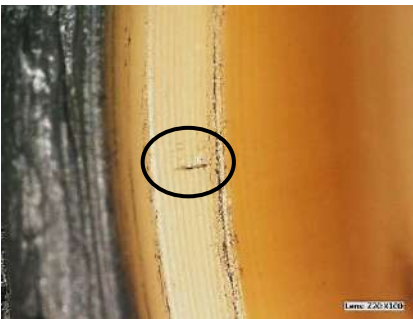
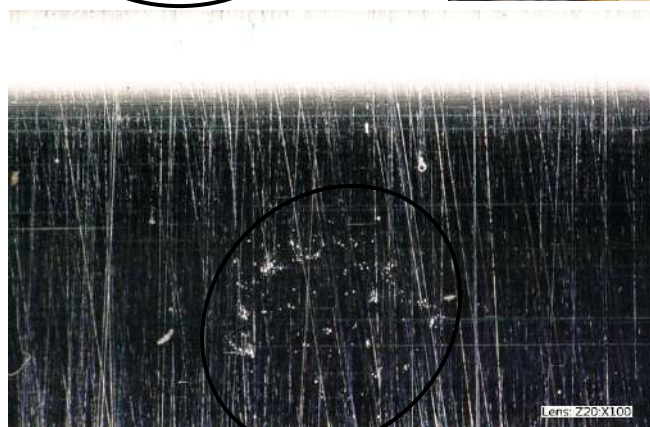
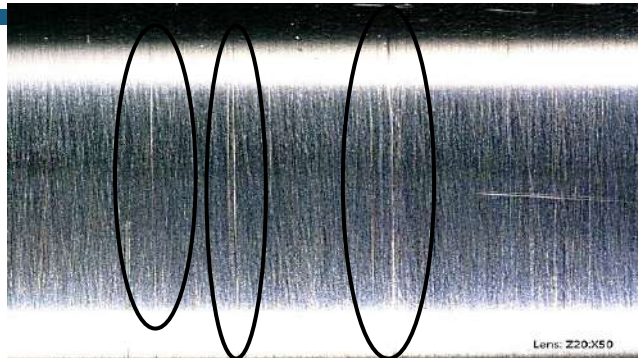
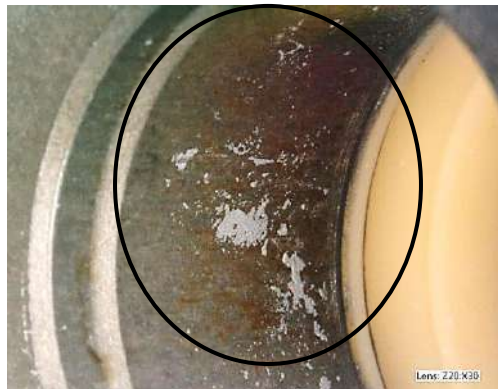
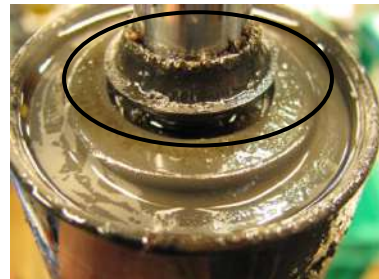
- Resistance: 1.26 - **OK**
 - Spec: 1.28 ± 0.2 Ohms
- Preload: 249 - **NG**
 - Spec: 432 ± 40 N
- Stickout: 62 - **NG**
 - Spec: 33.0 ± 3.0 mm
- Piston rod surface finish measurement: **NG**
 - Spec: 0.040 Ra Max
 - Measured: .0214 to .0537 Ra **NG**

- Deep scratches **NG**
- Rust accumulation on bearing
- Rod surface finish does not meet spec **NG**

- Dislodged wiper seal allowed for contamination to come in contact with the rod, scratching and damaging the rod. The damaged rod compromised the seal and allowed fluid and gas leakage

- Gen 2.5 Rod guide assembly put into production 1/12/2018
- Implemented 100 grit rough grind wheel, and improved machining parameters 3/23/2018

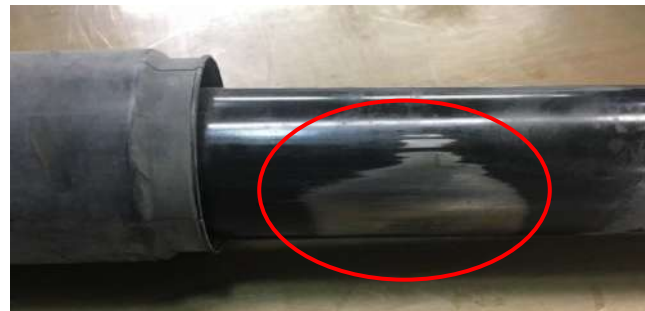
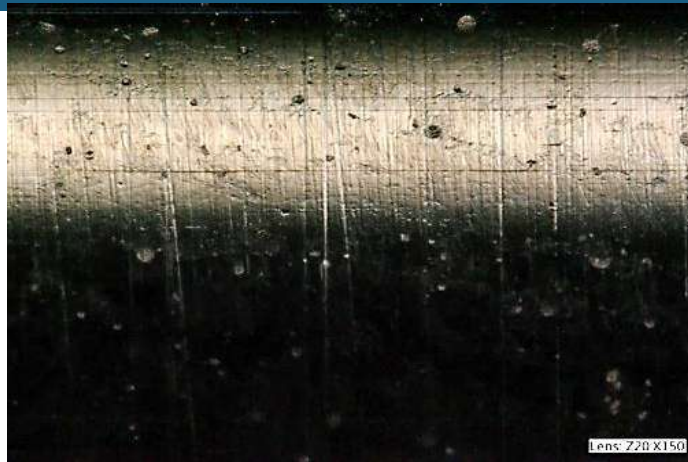
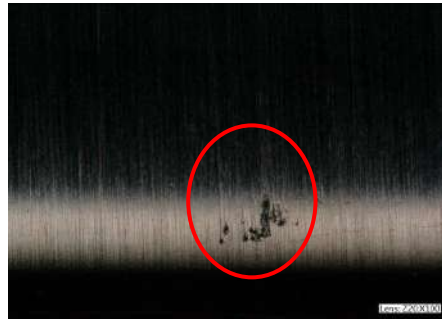
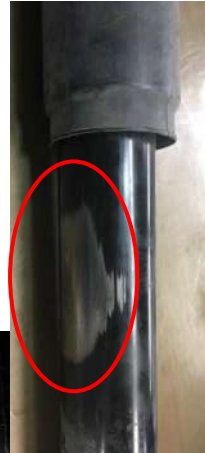
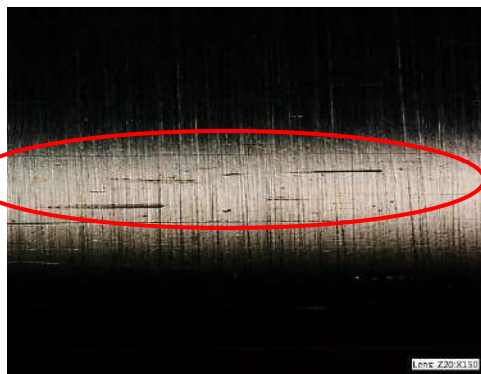
- Damper build date: 1/8/2018
- Model: 2017 XTS Rear
- VIN: 2G61U5S36H9167464
- Mileage: 74,475
- State: TX
- Cause: Noise

- Wiper seal dislodged from cover assembly
NG
- Wear on reservoir tube from dust shield
NG

- Resistance: 1.26 ohms - **OK**
 - Spec: 1.28 ± 0.2 Ohms
- Preload: 376 - **NG**
 - Spec: 432 ± 40 N
- Stickout: 29 - **OK**
 - Spec: 33.0 ± 3.0 mm
- Piston rod surface finish measurement: **NG**
 - Spec: .04 Ra Max
 - Measured: .0288 to .0495 **NG**

- Deep scratches, “watermarks,” and comets on rod **NG**
- Some accumulated rust on bearing due to wiper seal allowing contamination into the bearing **NG**

- Wear on outside of reservoir tube indicates dust shield wearing on reservoir tube causing noise
- **Corrective Action:**
- Gen 2.5 Rod guide assembly put into production 1/12/2018
- Implemented 100 grit rough grind wheel, and improved machining parameters 3/23/2018
- **Dust shield rubbing corrective action TBD**
