**United Nations Global Compact
“Communication in Progress” (COP)
Report on Ghana Manganese
Company Limited**

March 22, 2011

EXECUTIVE SUMMARY

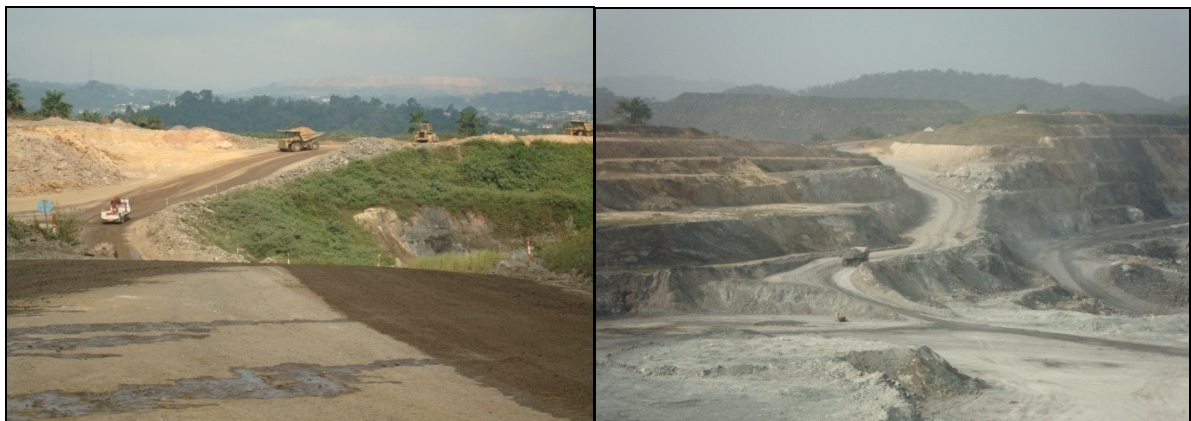
From the recommendation of the 2010 LOM, the pit shell has been extended to enable maximum extraction of the ore body and to ensure slope stability. The areas which fall within the pit shell needs to be developed to open–up so as to achieve the aims of the extended life of the mine. The pit has been designed as per standard bench heights and slope and to reach the ultimate pit bottom. Plate 5 and 6 show initial and progress stages of Pit C.

Plate 5: Pit C before development. Plate 6: Pit C under development.

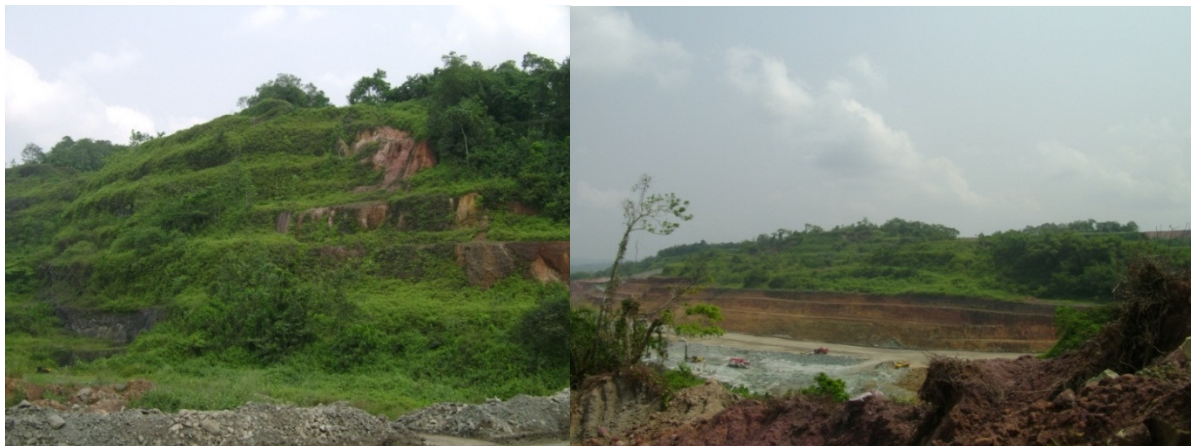
Plate 7: Pit C before development.

Plate 8: Pit C under development.

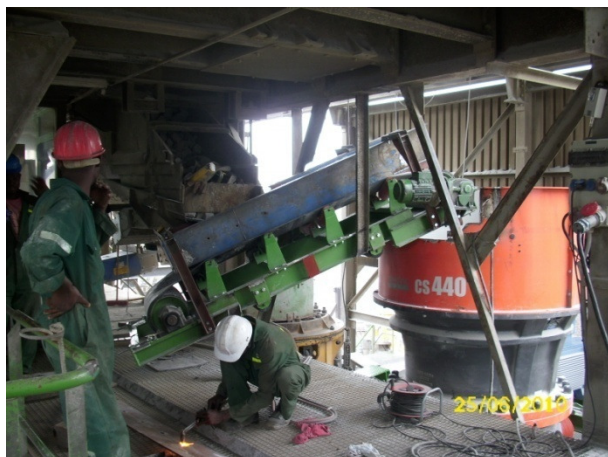
- New Cs Cone Crusher
- New Feed Belt

*Plate9: New feed belt
Crusher*

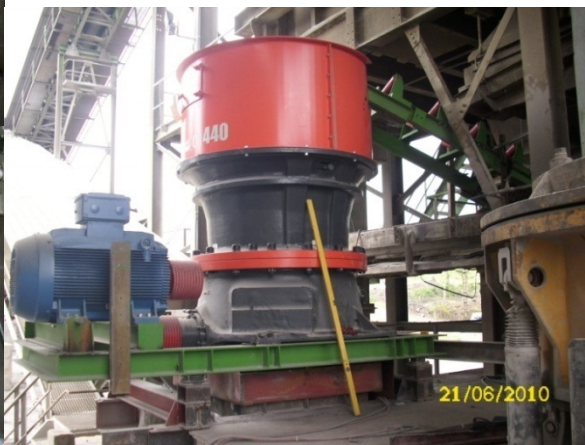
The new CS 440 Cone crusher replaced old s- 2000 Cone crusher to prevent the following deficiencies;

- a. -Feed opening too small to handle big top size material
- b. – Causing too many chokes during operation resulting in high downtime
- c. – Burning of Vee belts
- d. – Surge bin becoming full because of slow feeding causing too many recycling

Cs 440 Cone Crusher provides the following efficiencies:

1. – Maximizing productivity
2. – Easy to operate
3. – Maximum feed and close side settings are good
4. – Eliminate recycling of material
5. – Capacity and performance is good
6. – Crusher can handle more top size material and pass it on to the tertiary crusher if the need arises to increase high grade fines recovery

Plate 10: New Cs 440 Cone

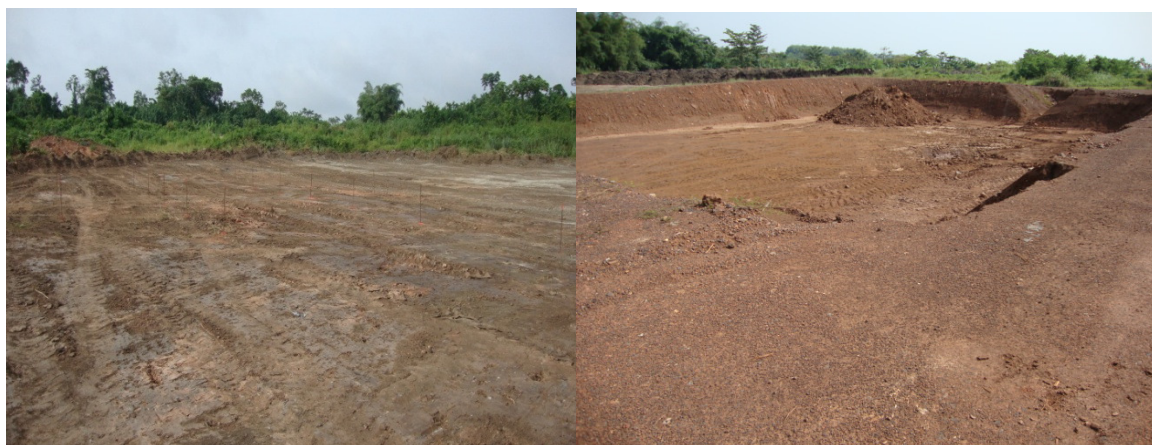
Construction of a Volatilization pad for contaminated soil generated on the mine is underway. The pad is to be lined with HDPE liner to prevent underground seepage and equipped with sacs (oil spillage kits) to separate oil from run-offs emanating from the contaminated soil during rainy season. The pad is sited at Pit “A” close to the domestic waste dump. Plate 11 and 12 below shows the Volatilization pad under construction.

Plate11: Volatilization pad ground preparation Plate12: Volatilization pad under construction.

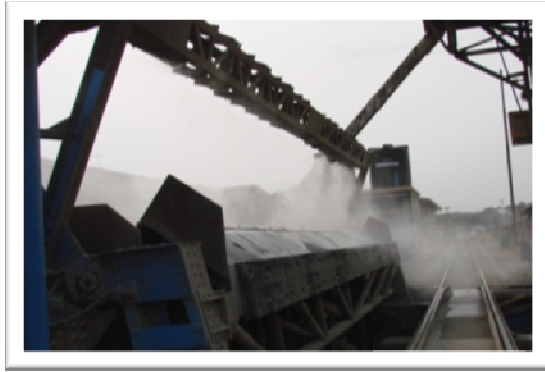
A Fog Maker dust suppression system has been installed at the Takoradi Port to ensure effective dust suppression on the tippler and transfer point between number 2 and 3 conveyors (plate 13) and also at the transfer point between number 3 and 4 conveyors (plate 14). The high-pressure water mist dust suppression system was customary developed by the GMC Electrical Department.

Plate 13: Fog Maker at tippler

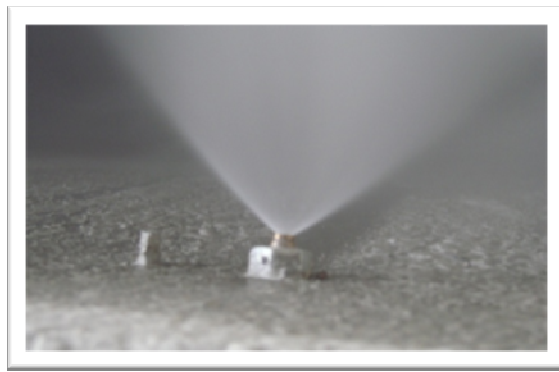
Plate 14: Fog Maker high pressure nozzle

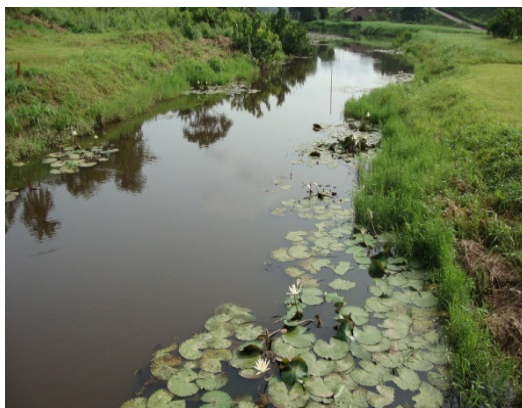
Plate 15: shows water weeds colonizing

In order to maintain or preserve our water bodies, a thorough de-silting exercise was carried out in the streams, which involved the removal of water weeds in the main reservoir, de-silting of the Tarkwa Banso canal and other drainage systems on the mine. Choked drains were cleaned and general hygienic condition on the mine was undertaken. The oil separator and the washing bay were de-silted to ensure proper functioning of the facility. Plate 15 and 16 shows water weeds colonizing Kawere stream and de-silting gang at work removing the weeds.

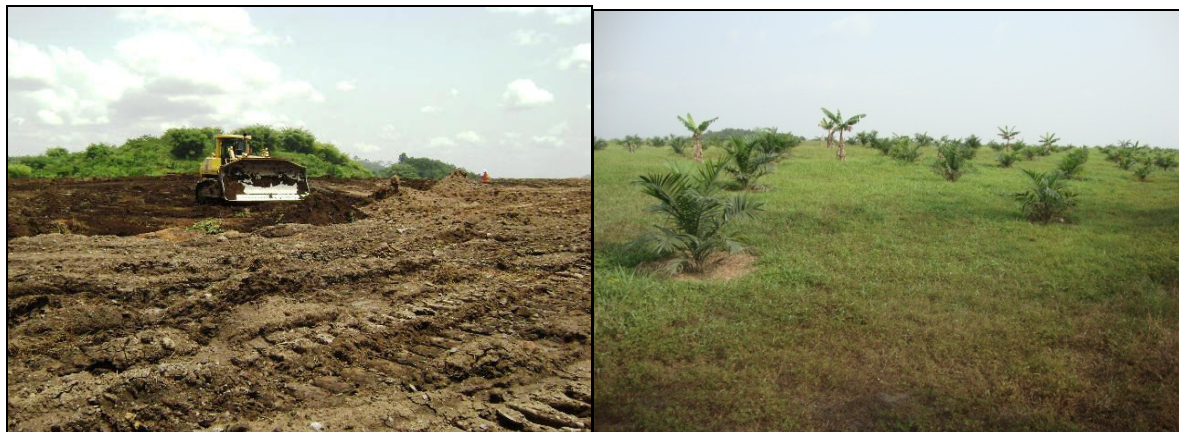
Plate 17: shows spreading of topsoil Plate 18: shows current state of the palm seedlings.

Weeding, line pegging and digging continued alongside with the planting. A total of one thousand five hundred (1,500) hybrid tenerra oil palm seedlings were transplanted on the 20 acre land at Hill B reclamation site. The oil palm seedlings were planted linearly of 8.6meters in width and 10meters in length. Global Positioning System (GPS) device was used to track the positions of all the species. The oil palm is intercropped with plantain as indicated in plates 13 and 14.

Terminalia superba “Ofram” and *Cinderella odorata* seeds nursery have been established on the Hill B reclaimed site to experiment the growth rate using undisturbed lands as a control measure. The experiment reveals that germination and growth rates were faster than the control points due to the topsoil type and the plant nutritional value. Plate 17 and 18 shows dozer spreading topsoil and current state of the palm seedling sat the Hill B reclaimed site.

There are positive signs of good and firm rooting. In addition to this, over six hundred (600) plantain suckers were intercropped with the oil palm. Wood shavings and saw dust from the mine’s carpentry shop is used for mulching and to provide nutrients as they decay.

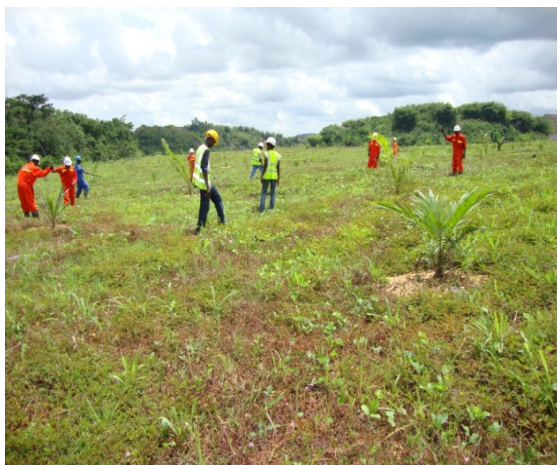
Plate 19: shows poor plant growth application

A 15:15:15 NPK (Nitrogen, Phosphorus and Potassium) was applied at a rate of 15g/plant. The method of fertilizer application used was ring method. By this method five (5) grams of fertilizer was scooped three (3) times using a tablespoon and placed around the lower parts of the palm tree within a radius of 15cm. To ensure faster mineralization, the fertilizer was stirred to incorporate it into the soil but care was taken not to damage the roots. This was done by the use of hand fork. The application was carried out as part of the CSIR recommendation and because some plants were growing poorly indicating low nutrient content. Plate 19 and 20 shows the poor plant growth rate of the palm seedling before applying fertilizer and signs of better growth after fertilizer application.

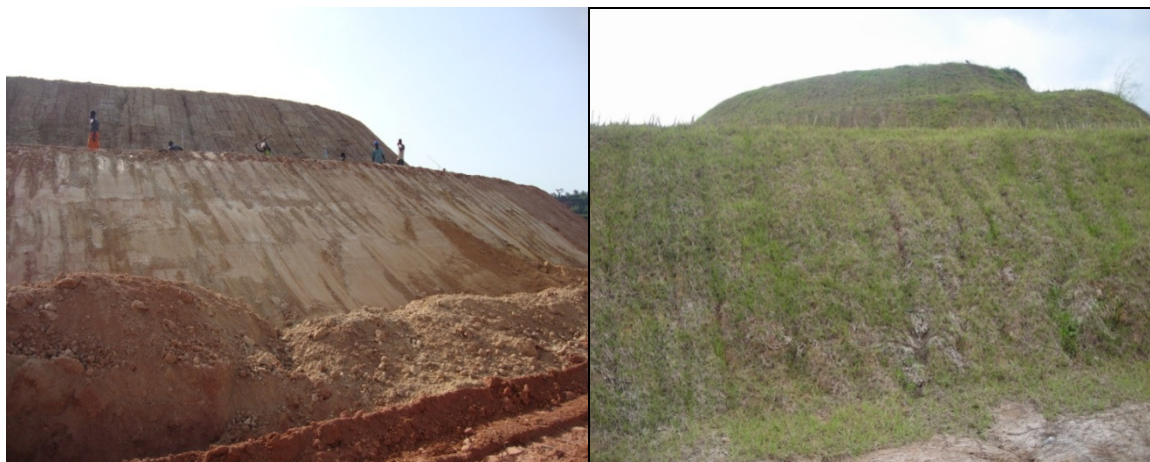
Re-vegetation of the newly constructed slopes of the Pit C central western footwall is an ongoing process at the PIT C. The stability of the final pit footwall left at the end of mining operations is critical to the successful rehabilitation of the site. The main aim of this activity is to produce a stable land form after the mining and to mitigate the environmental effects of the mining. And again rehabilitation on the other hand is a measure or an action used to remediate land disturbed by mining operations. At the pit c, benches were constructed at angles of 57° with the height of 5-8 meters. A number of drainages were constructed to check erosion on the berms. The success of every reclamation/rehabilitation project cannot be achieved without considering the various environmental best management practices.

Some of the best management practices adopted in the re-vegetation project include construction of drainages, Jute mat laying, and planting peruria, Vertiver and Buffalo grasses, Stone ditching. Plate 21 and 22 shows a newly constructed footwall slope and a footwall slope re-vegetated.

Plate 21:shows newly constructed footwall slope

Plate 22:shows footwall slope re-vegetated

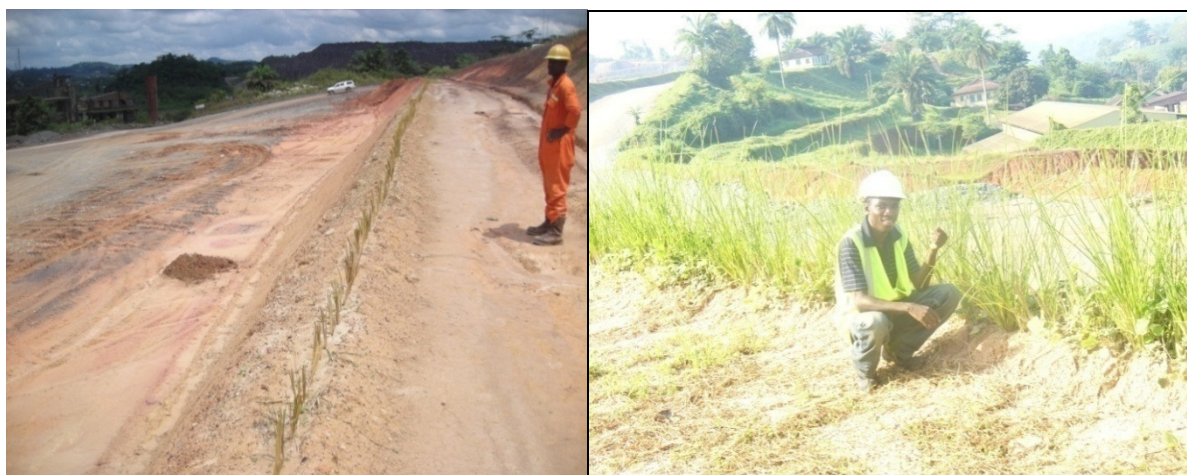
The roots and leaves of the grass species were trimmed before planting. This was done to reduce evapotranspiration of the species. Evapotranspiration is the return of moisture to the air through evaporation from the soil and transpiration by plants. Plate 23 and 24 show early stage of vertiver and growth weeks after planting.

Plate 23: Early stage of planted vetiver

Plate 24: some weeks after planting

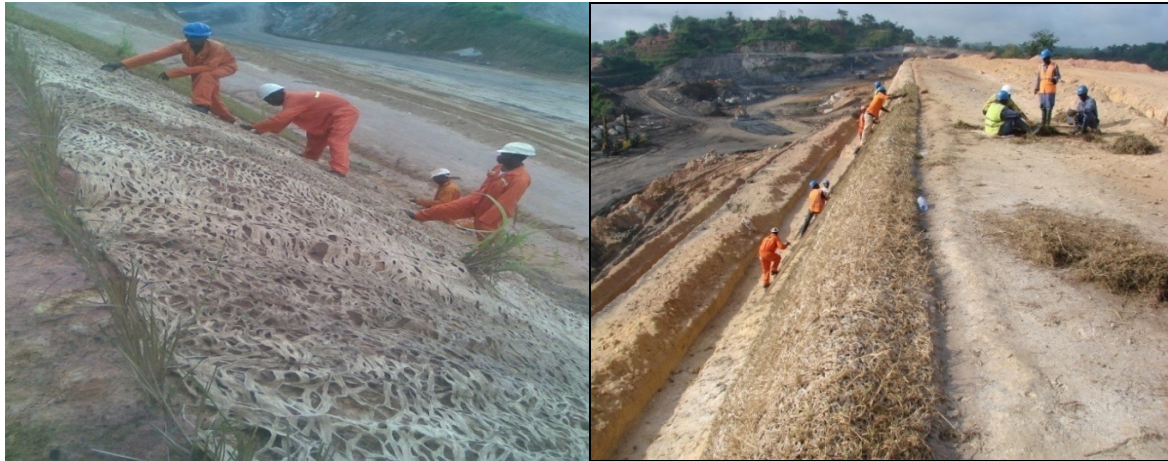
Jute mats are biodegradable materials that decompose with time when spread at a degraded site. These are made from the bark of a York tree called *Broussonetia papyrifera*. These were spread in order to trap the runoff sediments, prevent siltation and stabilize the soil before grassing is ensued. Plate 25 and 26 shows spreading of jute mats and planting of grow of grass.

Plate 25 shows: Spreading of jute mats

Plates 26: shows planting of growing grass

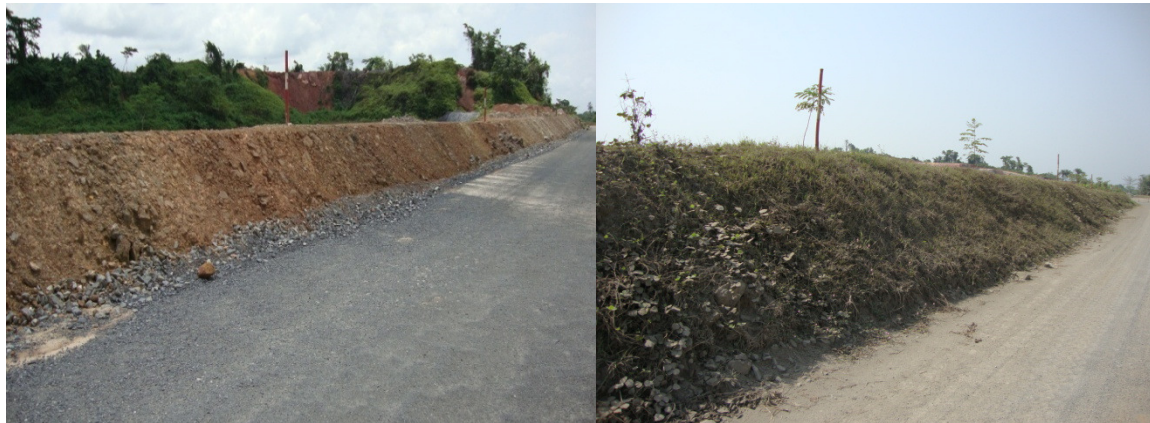
Grassing of windrow sand disturbed lands are part of GMC's erosion control practices aimed at reducing erosion and silt transportation into nearby water courses. Spreading of *Peruvia* seeds and planting of carpet and love grass along the newly constructed windrow from the washing plant to Pit C south western footwall was also carried out during the year under review. During the year under review, 147 *Leuceana* and *Acassia* seedlings from the nursery were transplanted; 47 seedlings were planted on the windrow at the washing plant, 89 seedlings on the windrow from Pit C Central West to the mining office junction and 36 seedlings

planted along the reservoir at the golf course respectively as indicated in Plate 27 and 28 showing grassing of windrow.

Plate 27: shows windrow under grassing. Plate 28: shows windrow after grassing.

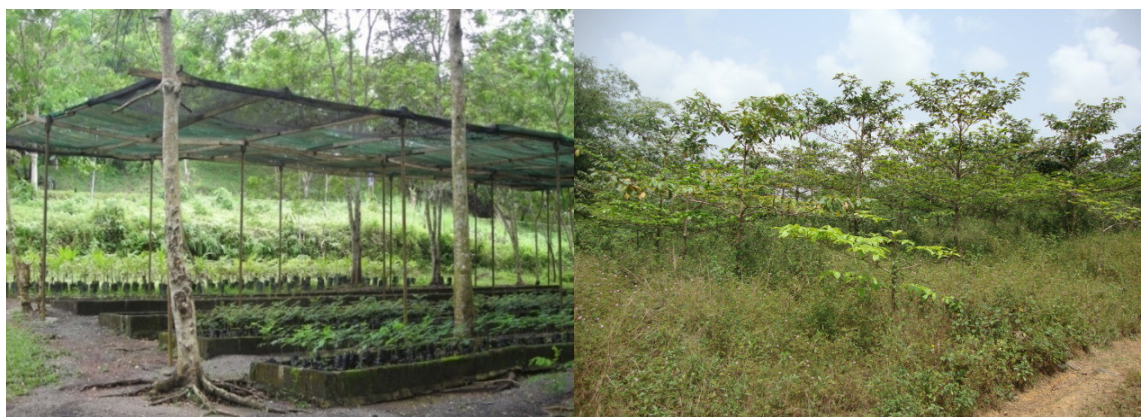
Plate 29: nitrogen-fixing tree seedlings nursed. Plate 30: shows current state of the reforested area

Reclamation programs in the Teak and Ofram afforested areas was vigorously pursued during the year under review to promote ecological integrity of the site and surrounding landscapes. This ecological restoration was achieved through the establishment of nursery. Routine agronomic practices including weeding and watering were carried out for all the plants on the rehab and those at the nursery respectively. Plate 29 and 30 nitrogen-fixing tree seedlings nurse and reforested area.

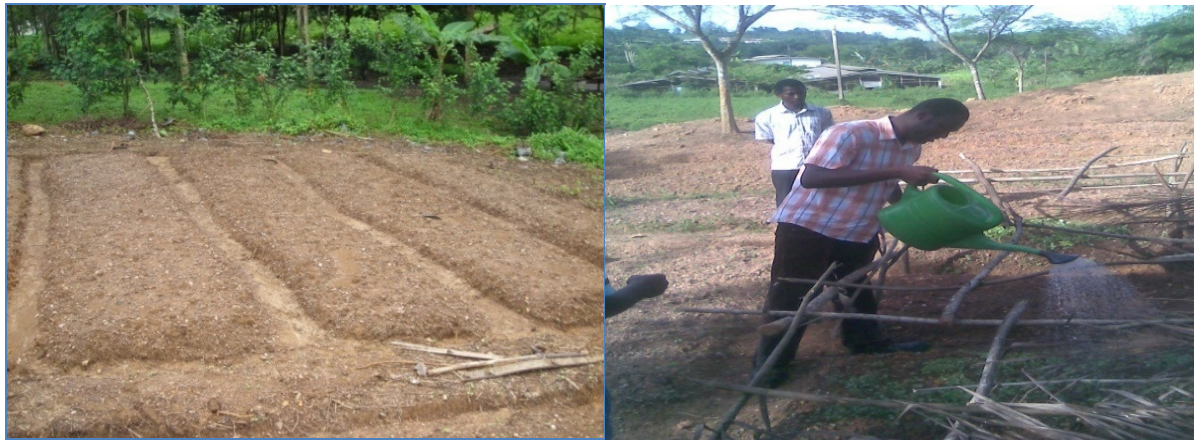
A total of forty (40) beds were constructed, four (4) of the beds were used as germination beds and the remaining ones were used as transplant beds. The size of the germination bed is 0.5m×1.5m was constructed to nurse Cabbage, Sweet pepper, Cucumber seeds. The germination beds were raised up to a thickness of 5cm. Broadcasting of seeds took place after the construction of beds. Prior to the germination of the seeds, the beds were covered with palm fronds, which ensure suitable temperature, high moisture content and regulated amount of light essential

for germination. Plate 31 and 32 shows Germination beds and watering of germinated seeds.

Plate 31: shows Germination beds

Plate 32: shows watering of germinated seeds

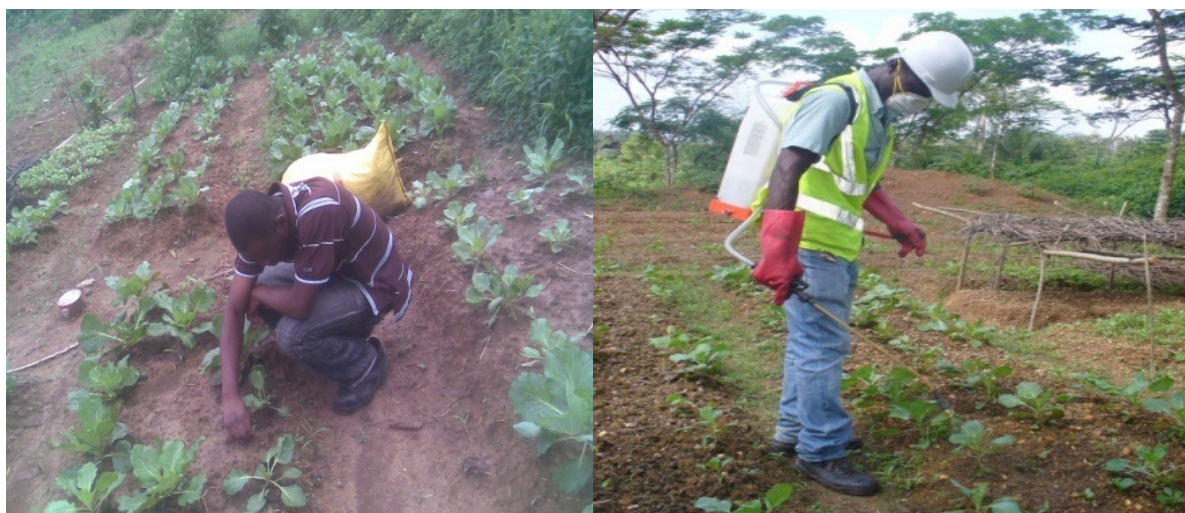
Application of insecticide to enhance growth was also carried out. In order to reduce damage caused by these defoliators and get rid of them, the transplant beds were sprayed using PLAND EC a contact insecticide used for the control of general pest. Some of the insects found on the transplant included caterpillar, aphids, variegated grasshopper etc. Plate 35 and 36 shows spraying of seedlings with insecticide (20ml of PLAND EC and 15liters of Water).

Plates 35 and 36 show insecticide (20ml of PLAND EC and 15liters of Water) spraying of seedlings.

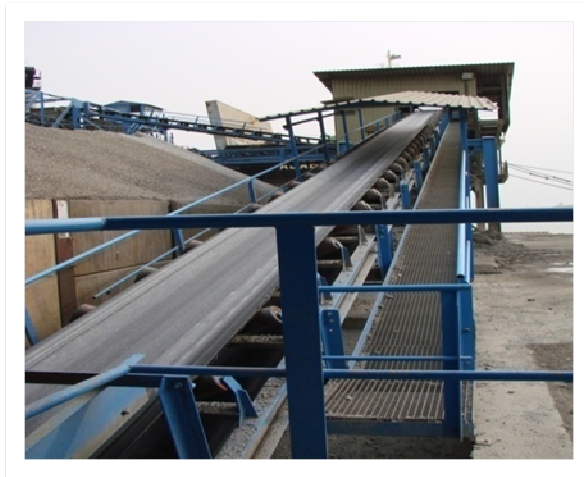
During the year under review, the following infrastructural and structural improvement projects were undertaken at the GMC Takoradi Port facility: A new conveyor structure was fabricated on site for number three conveyor belt. A new transfer house was fabricated at the transfer point between number 2 and three conveyors. Plate 45 and 46 shows a conveyor structure for Conveyor No3. Point and a new transfer house at the transfer between number 2 and 3 conveyors.

Plate 45: New conveyor structure for Conveyor No.3

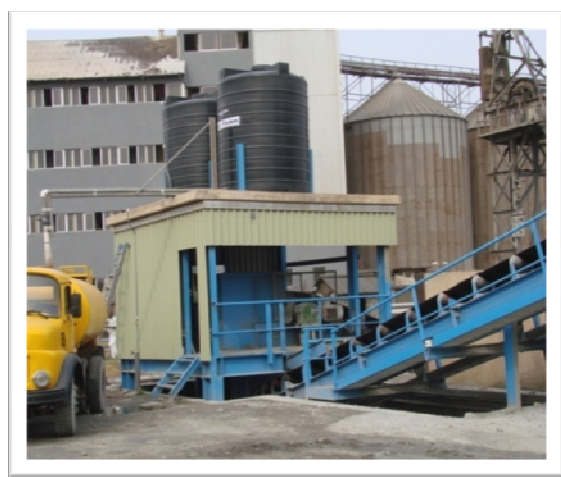
Plate 46: New transfer house at the transfer point between number 2 and 3 conveyors.

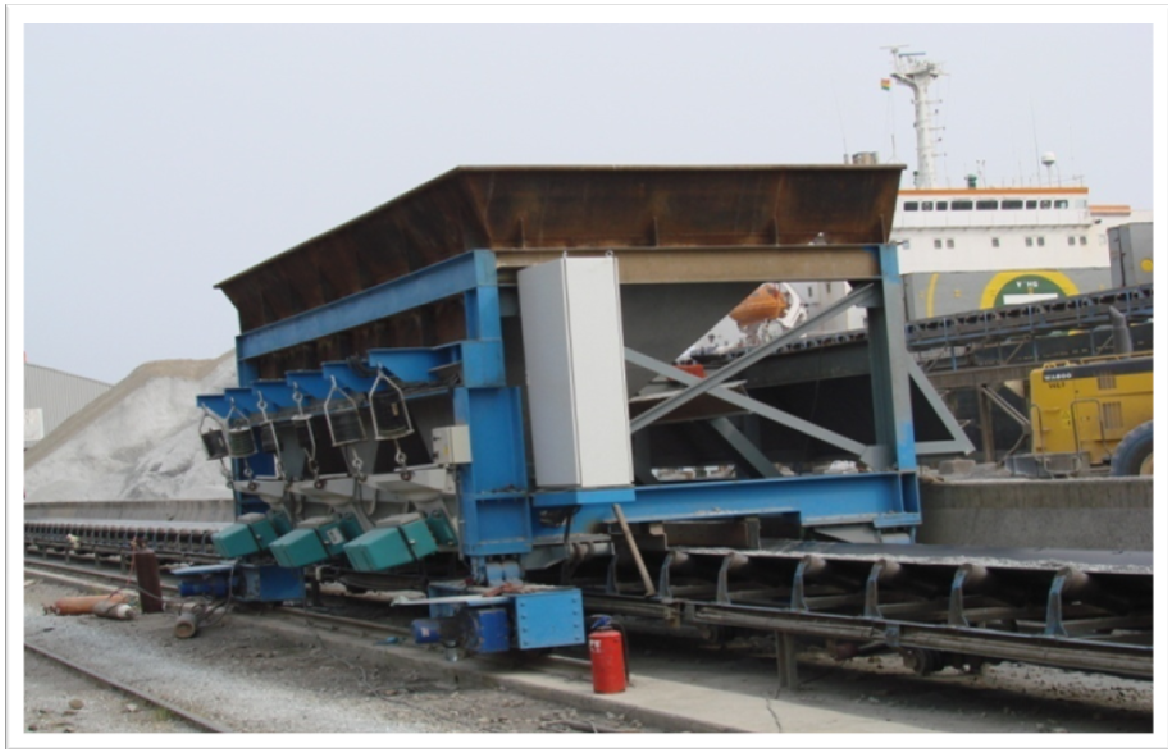
A new more efficient product feed hopper was built during the year under review. The purpose of the feed hopper is to assist in improving the vessel loading capacity at our port facility. The hopper runs on rails, which are parallel to the stockpile area. The hopper is fed by means of front end loaders and discharges onto number one product belt. Plate 47 below shows new product feed hopper.

Plate 47: shows new product feed hopper
