## EXECUTIVE SUMMARY

The Ghana Manganese Company Ltd. (GMC) owns and operates the Nsuta Manganese Mine, located in the Tarkwa-Nsuaem Municipal Assembly of the Western Regional Administrative Area in the South West of Ghana. The mine has been in operation for ninety-six (96) years and has a total concession area of 175km<sup>2</sup>. Its current mining activities fall within the 4.6km<sup>2</sup> whiles historical working areas and various infrastructures such as the Nsuta Village, Mine Offices, and Workshops add-up to form a total land take of 8.98km<sup>2</sup> utilized by the project site at Nsuta in the Dadwen Extension of the concession.

This Annual Environmental Report has been prepared in respect of the year under review (i.e. 2012). It projects the environmental improvements in and around the mine including assistance to the communities within the Awudua and Esuaso Divisional Stool Councils.

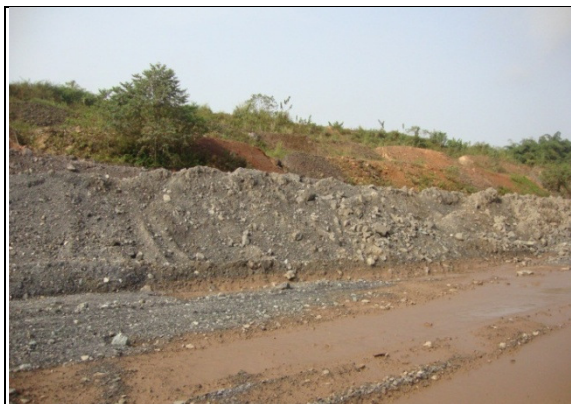
*Plate 1: subsoil stockpile*

During the year under review, sub-soils totaling 8,301,007 metric tons were generated from development of Pit C Central West, Pit C Central East, Pit C South West and Pit C South East footwall and magazine wall respectively. The sub-soil mined was stockpiled at the Hill B dump extension sub-soil stockpile for use during future closure reclamation/ rehabilitation works. Action was taken to prevent erosion of the stockpile and that was by broadcasting peruvia seeds. Regular inspections at the mine face to ensure correct buffer zone, bench and berm parameters that are in compliance with Akoben Criteria was carried out during the year under review. Plates 1 and 2 show topsoil and subsoil management.

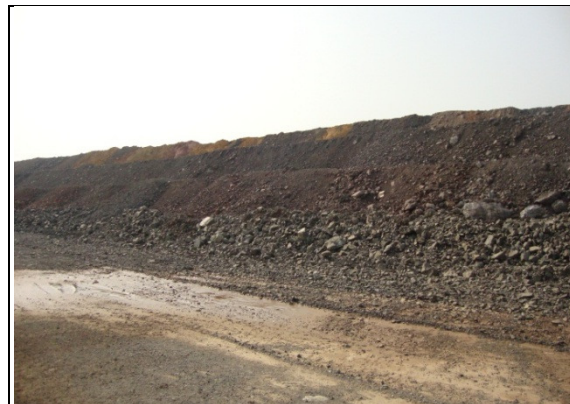
*Plate 2: Hill B stockpile under construction*

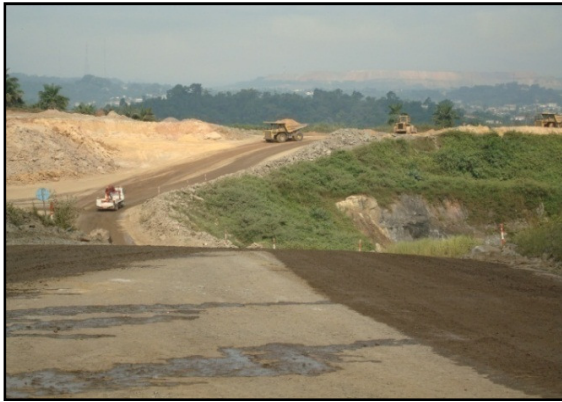
*Plate 3: Pit CCW before development.*

The LOM pit shell has been extended to enable maximum extraction of the ore body. The areas which fall within the pit shell needs to be developed to open-up so as to achieve the aims of the extended life of the mine. The pit has been re-designed as per standard bench heights and slope and to reach the ultimate pit bottom. Plates 3, 4, 5 and 6 show initial and progress stages of Pit C.

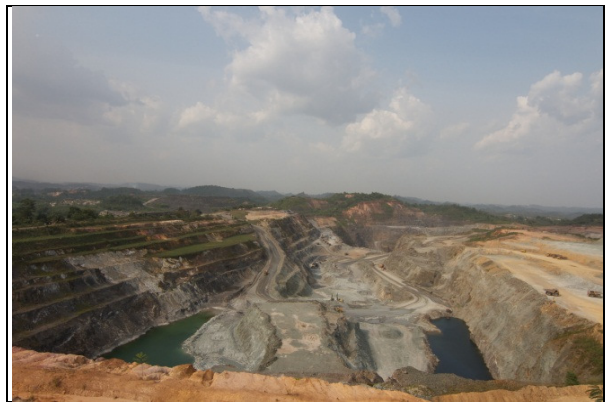
*Plate 4: Pit CCW under development.*

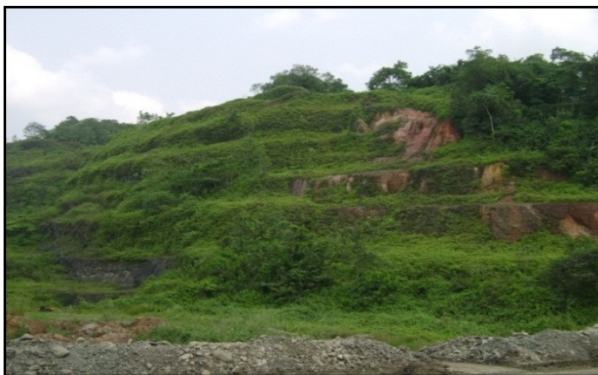
*Plate 5: Pit CCE before development.*

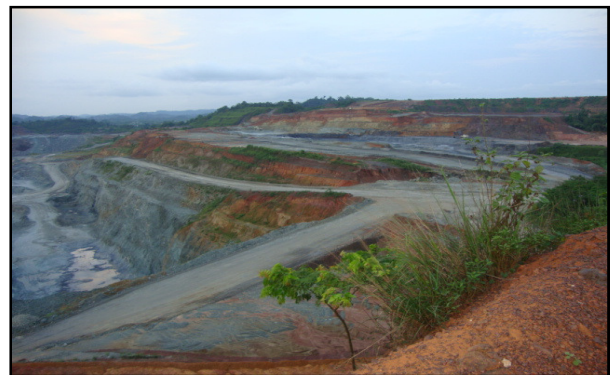
*Plate 6: Pit CCE under development.*

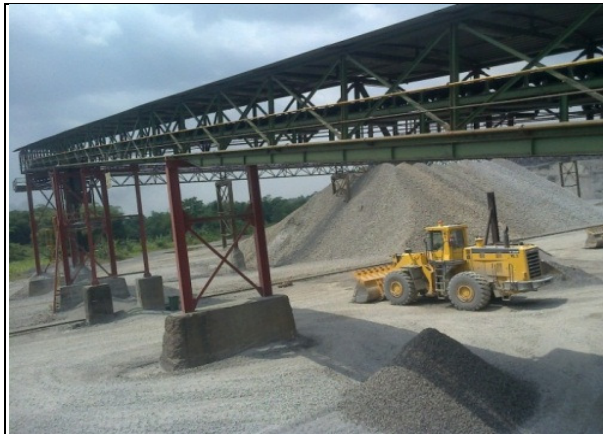
- 1 LUMP CONVEYOR: Replaced bad cross members;
- 2 LUMP CONVEYOR: Paint supports;
- SCREEN TOWER: Replaced two ladders.

*Plates 7: shows Lumps # 2 conveyor supports*

Plates: 7 and 8 show Lumps # 2 conveyor supports and Screen tower ladder respectively. Belt splicing awareness training was conducted as part of GMC Safety procedures.

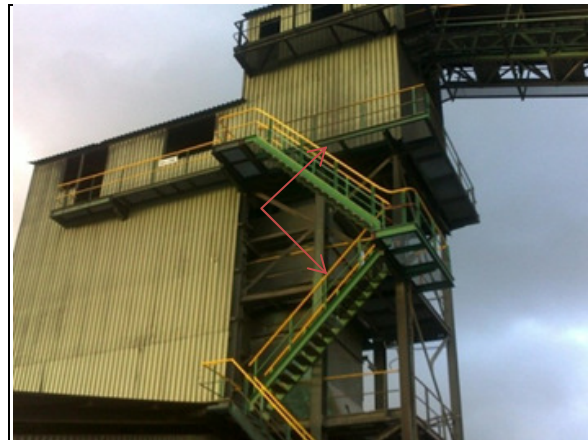
*Plates 8: shows Screen tower ladder*

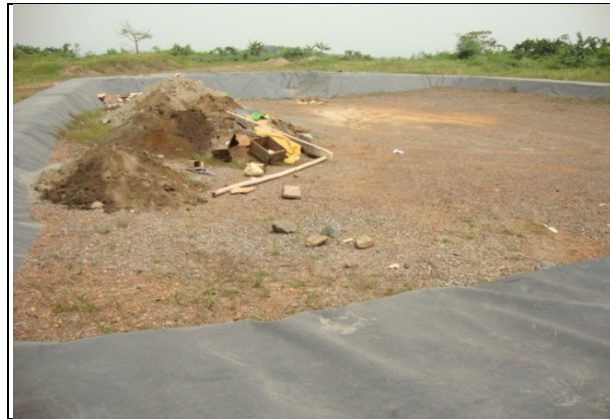
*Plate 9 shows volatilization pad under operation.*

The pad, which measures about 20m x 20m, is lined with HDPE on which subsoil is put and compacted. This facility has been in existence for the past two (2) years. Within the first year, the HDPE was stolen on two occasions in the presence of security personnel on guard. This prompted management of the company to fence off the entire area in 2012 in order to prevent or avoid the material being stolen. The fencing was done and the facility was dully locked.

The pad is sited at Pit A close to the domestic waste dump. Plates 9 and 10 below show volatilization pad under operation.

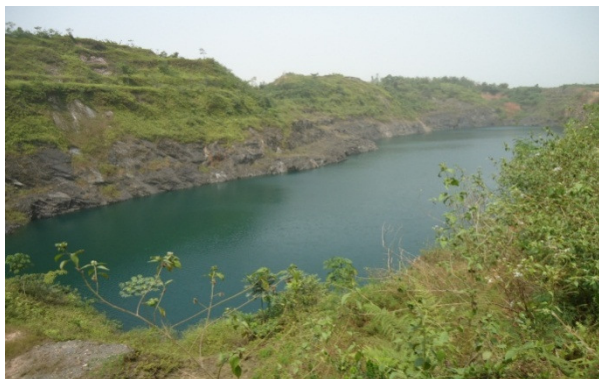
*Plate 11: View of GMC Pit B.*  
*area*

The water of PIT B was assessed for the physico-chemical, biological and elemental contamination status ahead of a possible discharge of water into the general environment to facilitate the continuation of mining of the pit. The study involved an in-situ assessment of the environmental parameters of ambient and water temperatures, total suspended solids (TSS), hydrogen-ion-concentration (pH), and dissolved oxygen (DO) among others. Water samples were also collected in acid-cleaned and rinsed sample bottles and transported to the laboratory for analysis of nutrients, microbiology and chemical elements. Eight heavy metals of ecological and biological importance including iron (Fe), arsenic (As), mercury (Hg), nickel (Ni), cadmium (Cd), manganese (Mn), copper (Cu) and lead (Pb) were collected and analyzed for their concentrations.

Pit B water meets the effluent discharge guidelines of the Ghana Environmental Protection Agency and thus discharging Pit B waters into the environment will present little or no ecological problems in the environment

The levels of heavy metals in water were very low. With the exception of Fe ( $0.066 \pm 0.015 \text{ mg/L}$ ) and all the elements investigated recorded values below the respective equipment detection limits. Fe in sediment samples however, had comparatively higher mean values at  $67.325 \pm 7.87 \text{ mg/g}$ . High levels of Fe in such environments are expected and would not be expected to present any danger to the environment as the bottom mud and substrata will be managed before disposal. Results of the analysis have been submitted to EPA in support for a permit to dewater Pit B.

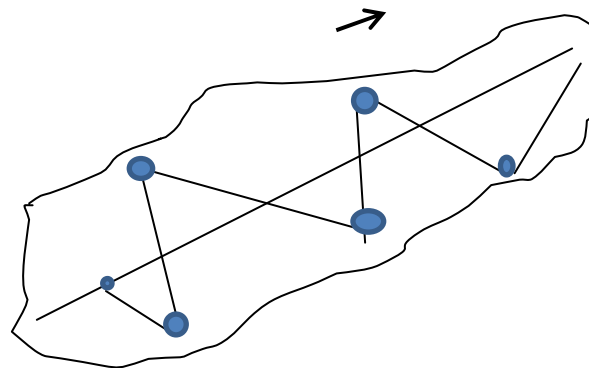
*Figure 1: Sketch of Pit B showing sampling area*

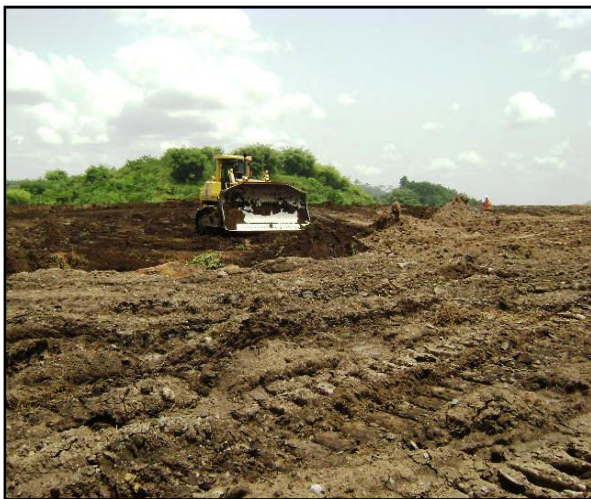
*Plate 14: shows spreading of topsoil seedlings*

The reclamation/rehabilitation of the Hill B waste dump was continued steadily for the year under review. In 2012 daily agronomic practices mostly weeding in and around the plantain and palm trees and application of NPK (15:15:15) fertilizers, pruning dead branches to improve aeration were carried out in the plantation to promote healthy growth and high yield.

Plantains inter-cropped with the palm trees, have started fruiting and on the average three bunches are harvested weekly to supplement workers and the hospital canteen. An appreciable quantity of cassava and plantain were harvested from the Hill B reclaimed site. See plates 14 and 15 above. The sizes of the crops (yield) were also found to be encouraging considering the maturity period of the crops. This is seen as a good indicator of the fertility of the soil at the reclaimed site.
