## EXECUTIVE SUMMARY

This Annual Environmental Report has been prepared in respect of the year under review (i.e. 2013). It projects the environmental improvements in and around the mine including assistance to the communities within the Awudua and Esuoso Divisional Stool Councils.

## **1.0 INTRODUCTION**

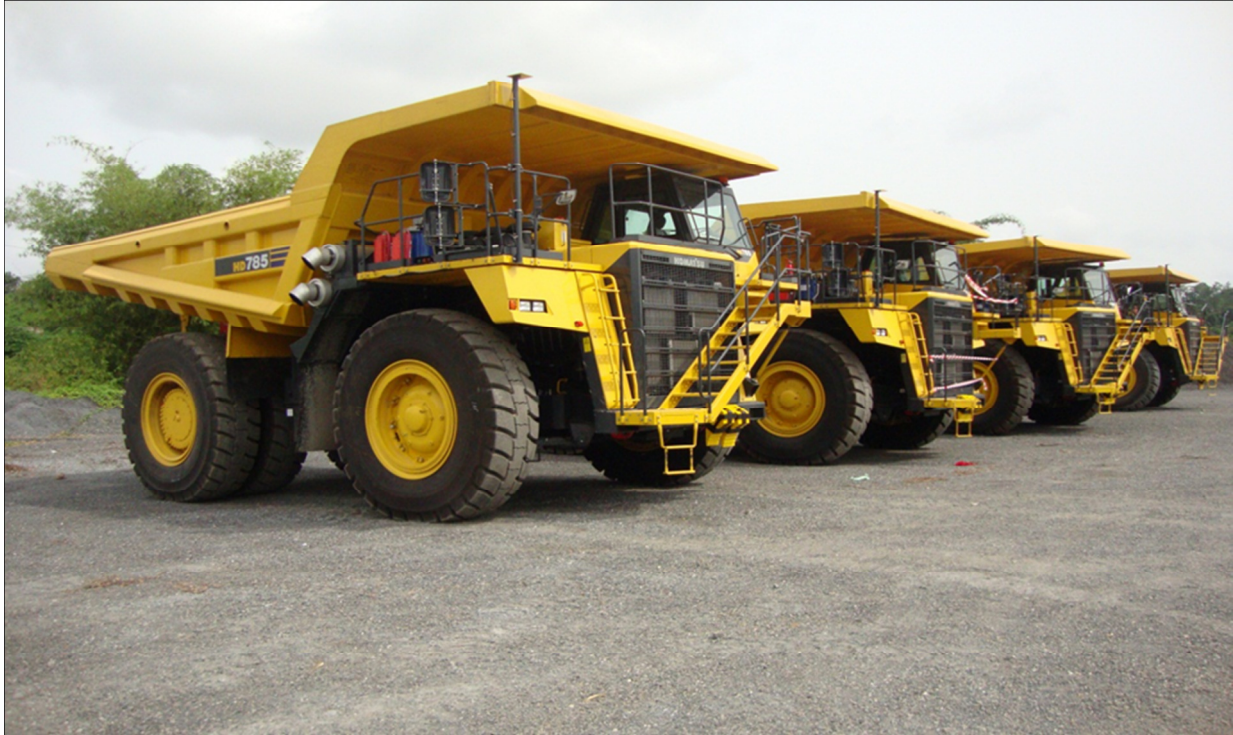
*Plate 1: Shows Komatsu 785HD-7 off highway dump trucks*

- 4 x Komatsu 785HD-7 off highway dump trucks,
- 1 x CAT D9R track type bulldozer,
- 1 x Komatsu PC2000-8 hydraulic backhoe,

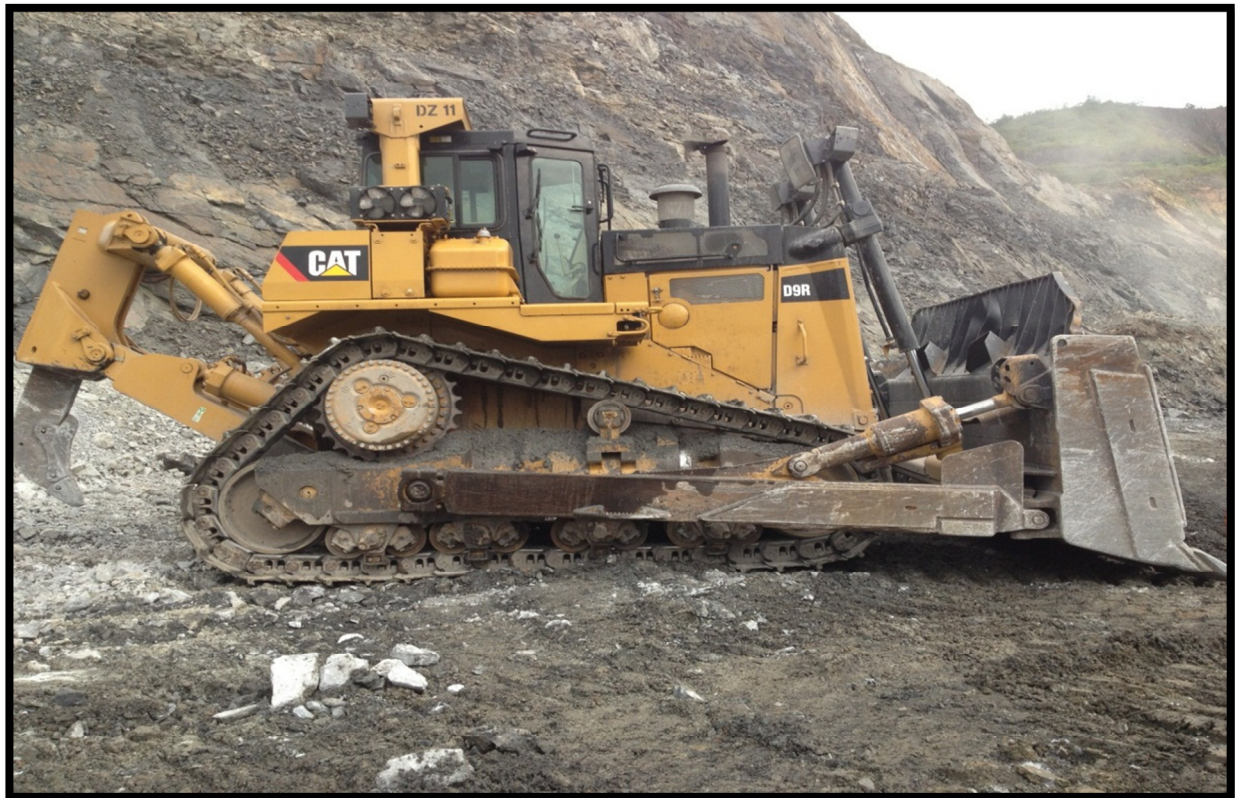
*Plate 2: Shows CAT D9R track type bulldozer.*

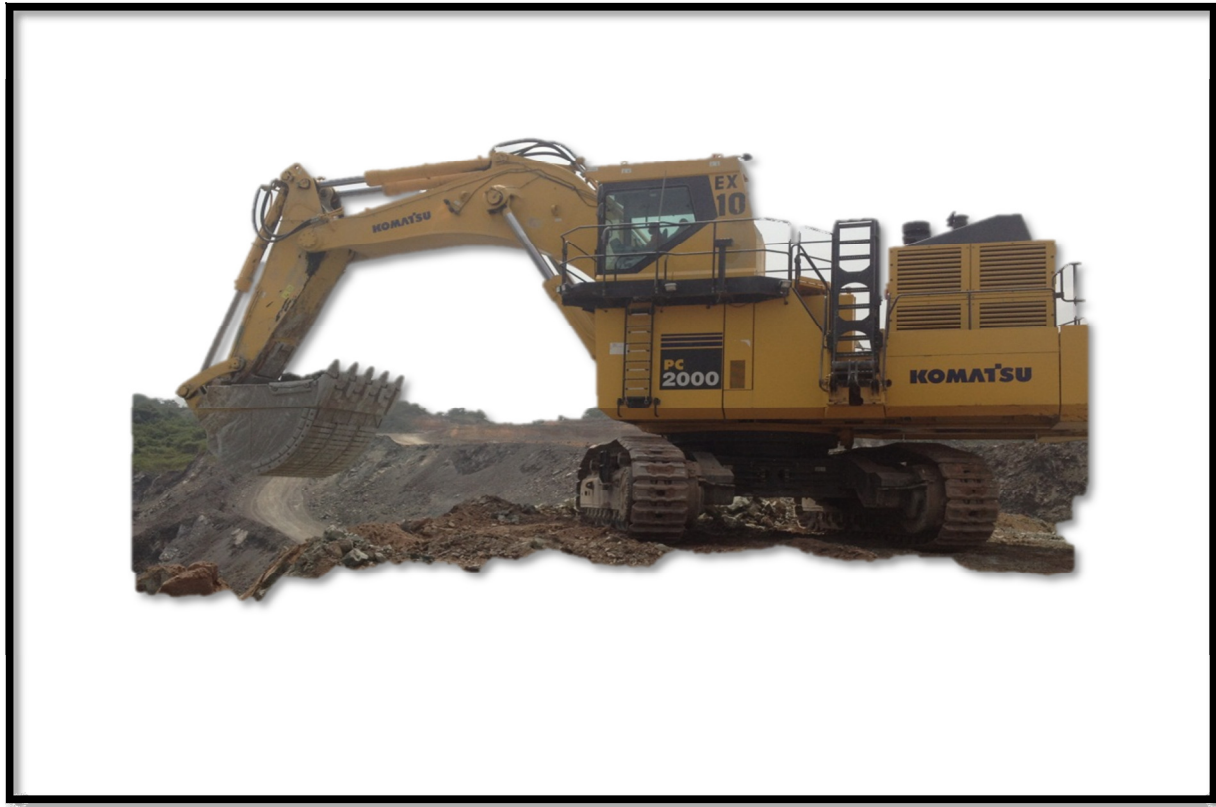
*Plate 3: Komatsu PC2000-8 hydraulic backhoe excavator*

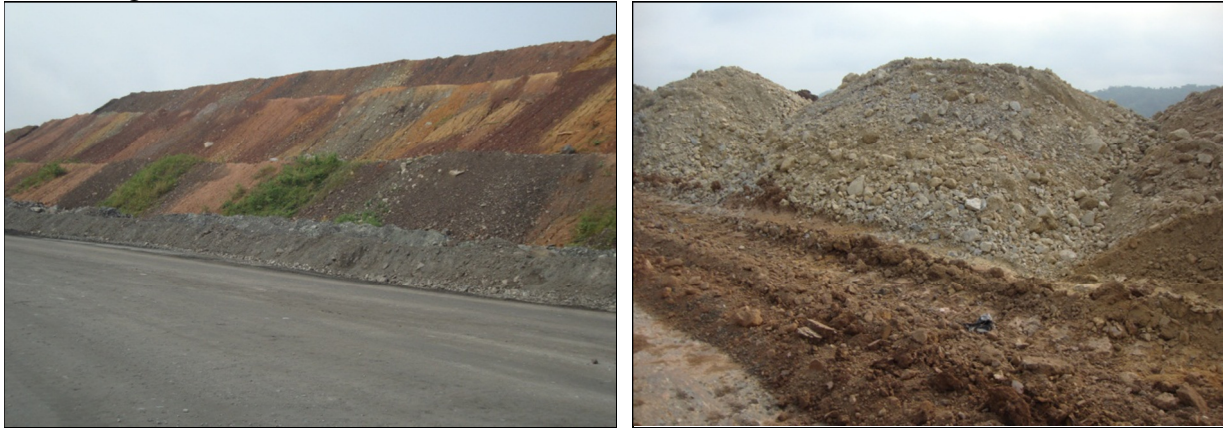
*Plates 4 and 5: Show topsoil and subsoil management on the mine*

During the year under review, sub-soils totaling 11,234,018 metric tons were generated from development of Pit C Central West (69,450), Central East (9,150,803), South East (1,245,898), South West (141,465) and Pit B footwall (626,402) were stockpiled at the Hill B soft dump for future closure reclamation/ rehabilitation works. To control erosion of the stockpile, pueraria seeds (leguminous cover crop) were broadcasted on its slopes. Regular inspections at the mine

face to ensure that buffer zone, bench and berm parameters are in compliance with Akoben Criteria was carried out during the year under review. Plates 4 and 5 below show topsoil and subsoil management on the mine.

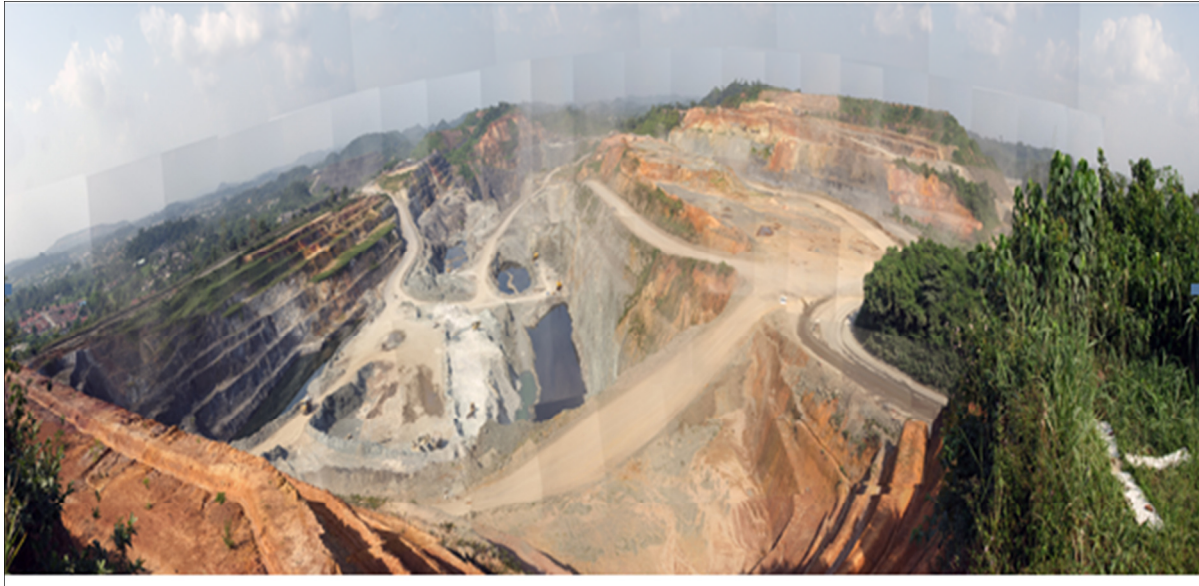
*Plate 6: Shows Pit C Development in 2013*

The LOM of the pit shell has been extended to enable maximum extraction of the ore body. The areas which fall within the pit shell needs to be developed to open-up so as to achieve the aims of the extended life of the mine. The pit has been re-designed as per standard bench heights and slope and to reach the ultimate pit bottom. See plates 6 and 7 for the initial and progress stages of Pit C.

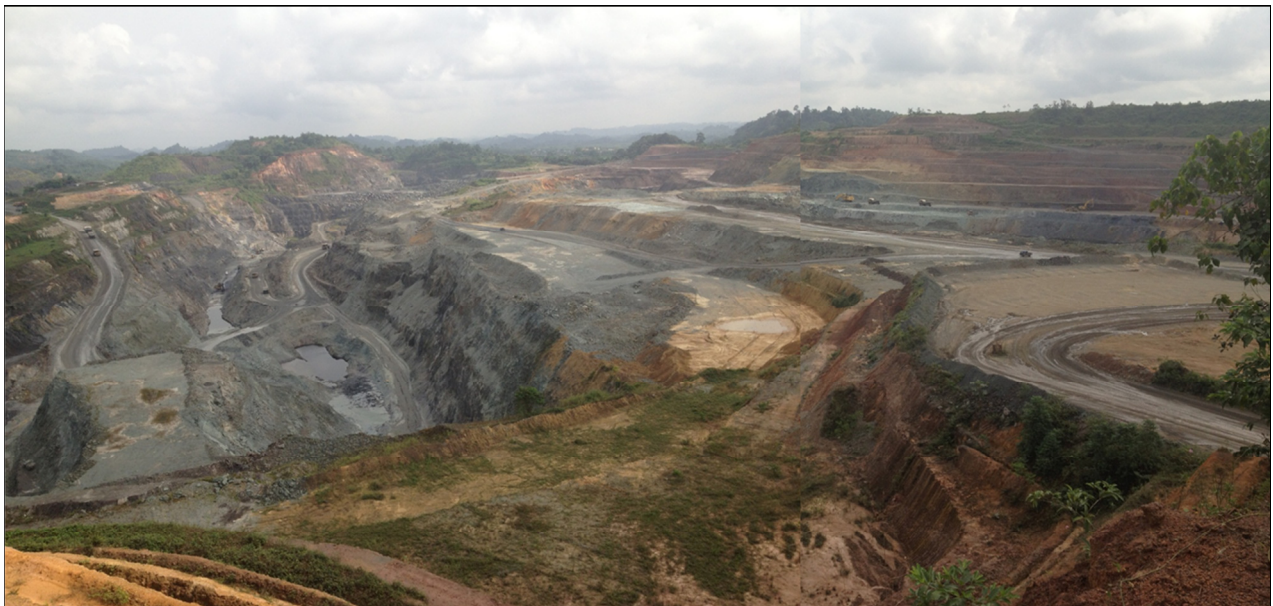
*Plate 7: Shows Pit C Progress development in 2013*

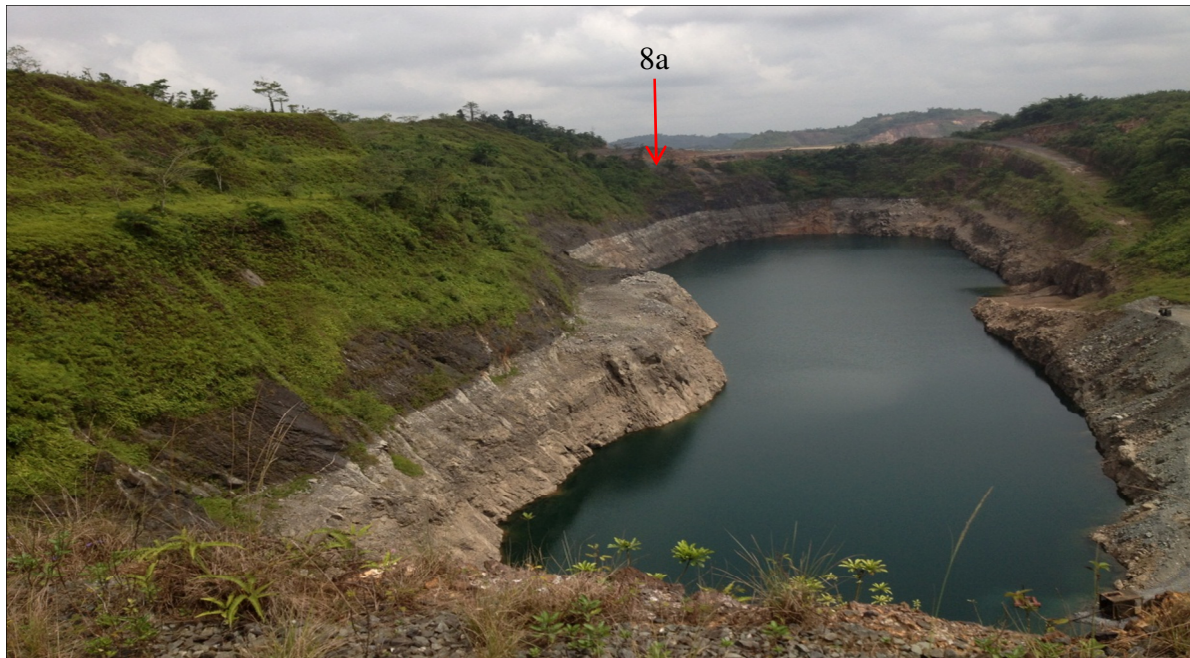
*Plate 8a: Shows Pit B Development in 2013*

Continuous exploration activities at Pit B has revealed that there is additional ore (manganese) dipping to the western limb (foot wall) of the pit. Upon optimization and design, a cut-back is being undertaken at the western side to open up access for the mining operations. This activity will affect the reclaimed Pit B North rehab site as mentioned in previous environmental documents. See Plate 8a: showing affected Pit B North rehab site in red arrow.

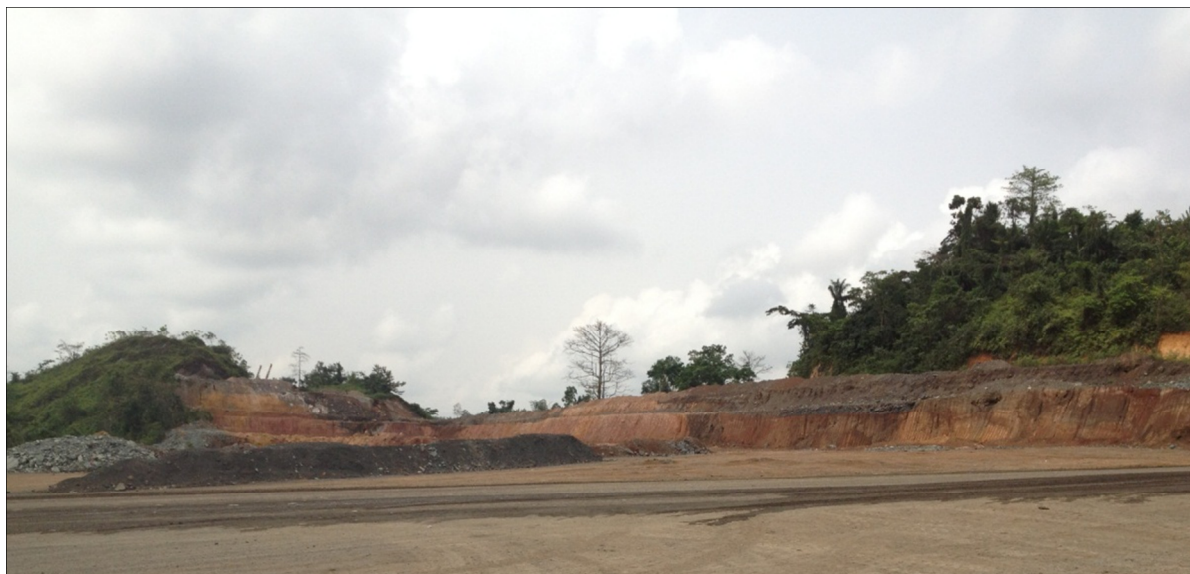
*Plate 8b: Shows Pit B Development in 2013*

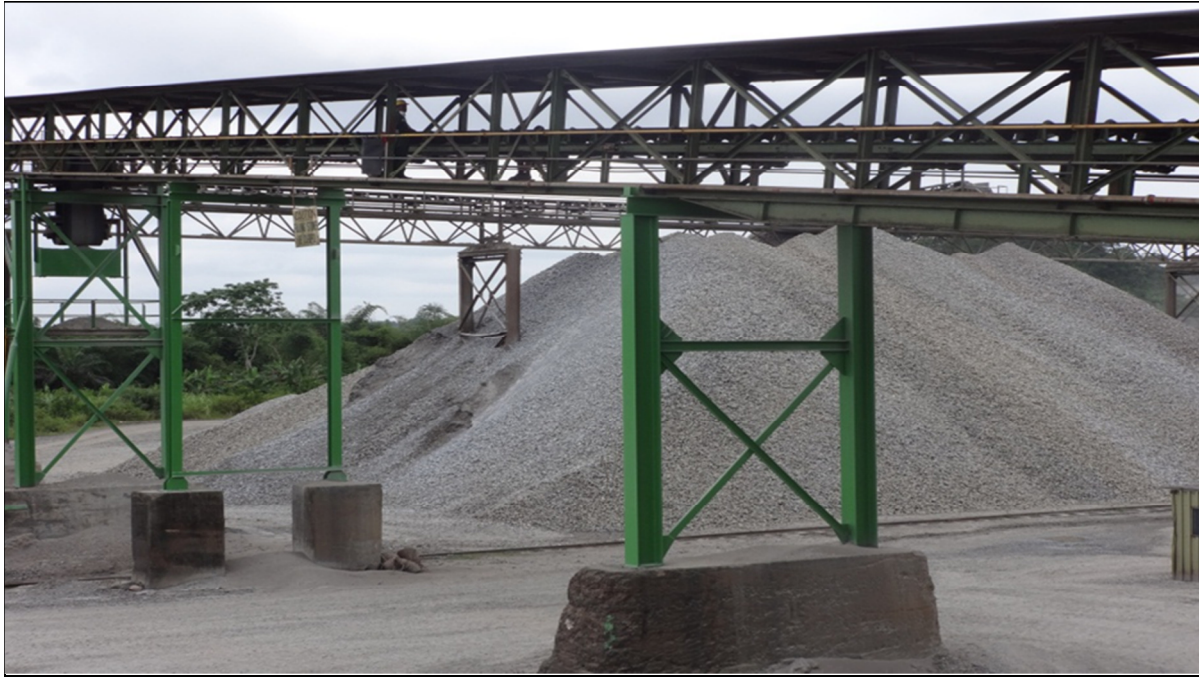
*Plate 9a: Shows painting of structures*

During the year under review, no major structural changes were undertaken in the plant, except modification and installation of new safety guards and installation of new dust suppression system (5 points). See plate 9a& 9b show painting of structures and side wall for primary section.

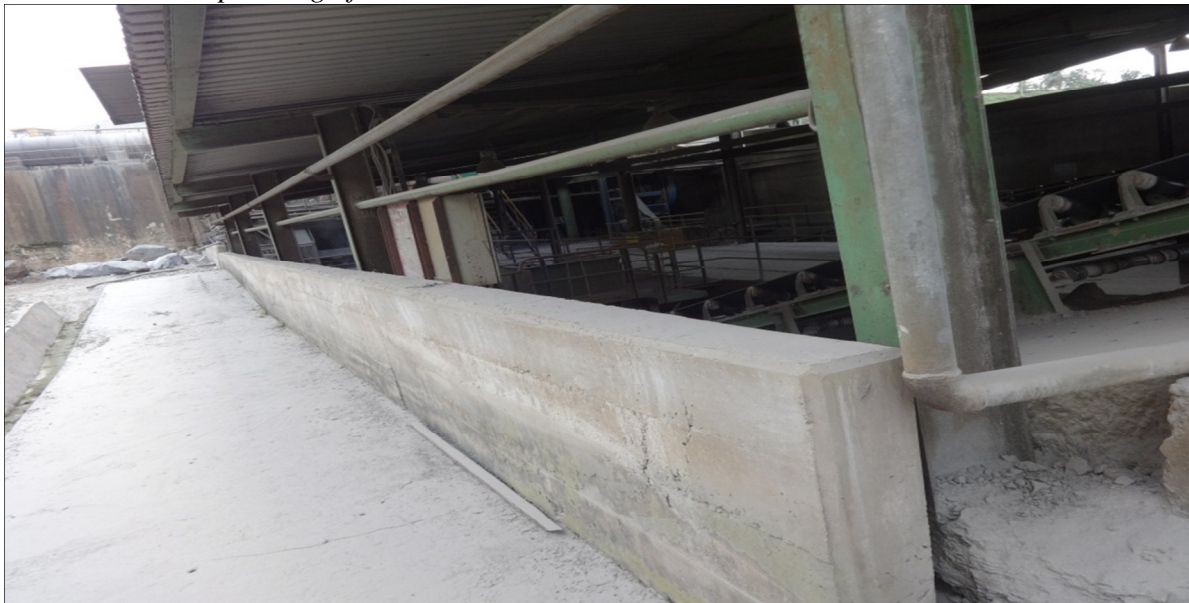
*Plate 9b: Shows new side wall for primary crushing section*

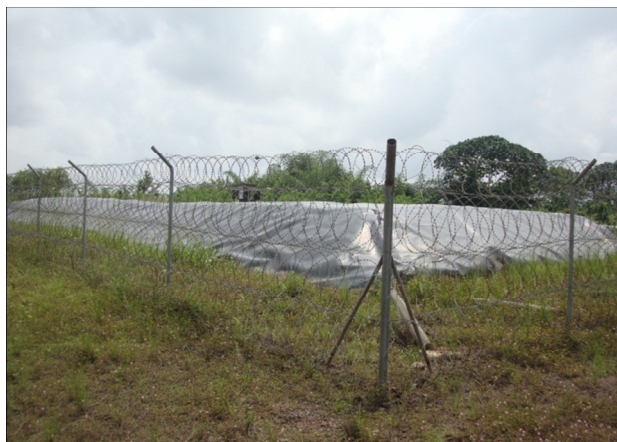
*Plate 10: Shows Volatilization pad fenced*

The pad is sited at Pit A close to the domestic waste dump. Looking at the destruction due to theft of HDPE liner at the volatilization pad, effective metal fencing around the facility was undertaken in 2013.

Since the erection of the fencing, no theft case has been recorded and the pad is functioning effectively. Oil Contaminated soil measuring about 345m<sup>3</sup> has so far been deposited in the pad and regular turning of the soil had effectively been done. This is to facilitate the decomposition or breakdown of the hydrocarbon compounds so that the soil could be used for agricultural purposes.

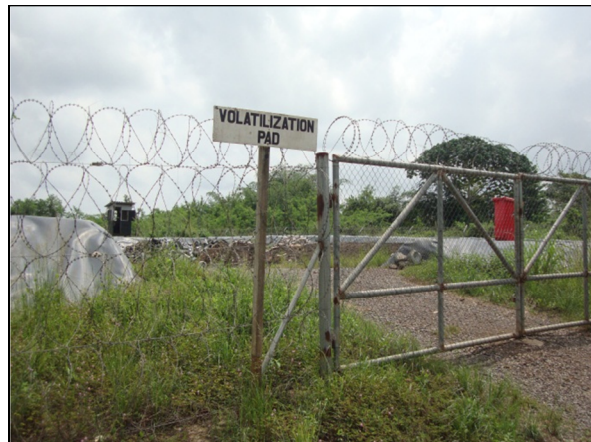
*Plate 11: Shows the entrance of the pad*

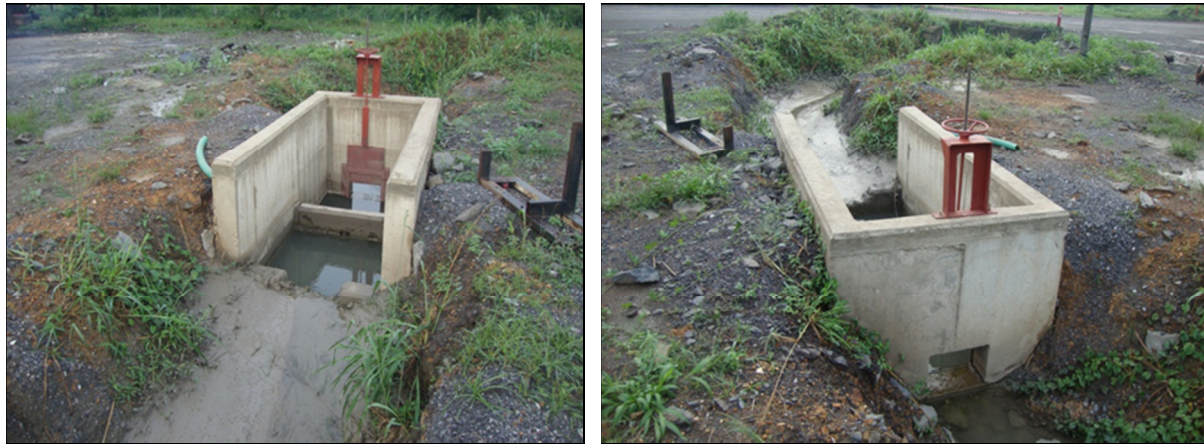
*Plates 12 and 13: ingress and egress sections of the storm water drainage with pen stock valve*

Four (4) other siltation ponds/traps were constructed to improve reduction of siltation of the Kawere stream. A Pen stock valve was installed on 5m<sup>3</sup> storm water settlement pond during the year under review to prevent unauthorized effluent discharges into the Kawere stream. The

number of spill kits on site is regularly reviewed along with relevant training in terms of spill drills to make sure there are always enough kits in stock and employees are capable of dealing with any major accidental release – safety first. Plates 12 and 13 show ingress and egress sections of the storm water drainage with pen stock valve attached to it.

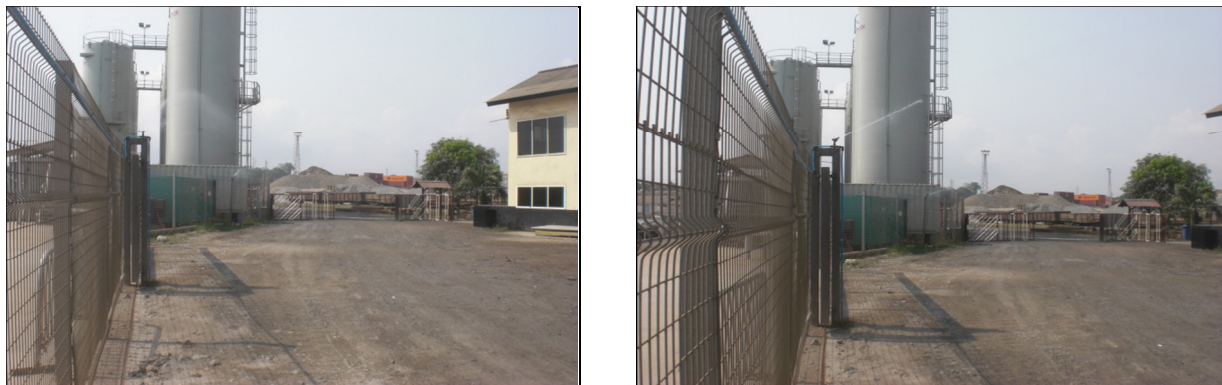
*Plates 14 and 15: Show water sprinkling systems suppression dust at Takoradi Port.*

As part of our continuous efforts to reduce dust concentrations within our operational area, Water Sprinkling Systems have been installed for dust suppression at the port. See plates 14 and 15 showing sprinkler systems in operation. The Sprinkler Device is operated by a Water Pumping Machine with a capacity of 4BAR/56PSI and a Rubber Hose.

The system rotates at an angle of 360 Degree when limit level is disengaged, with an adjustable mechanism. The maximum sprinkling distance is 25meters and a minimum of about 10meters. See plates 14 and 15 showing water sprinkling systems for dust suppression at the Takoradi Port.

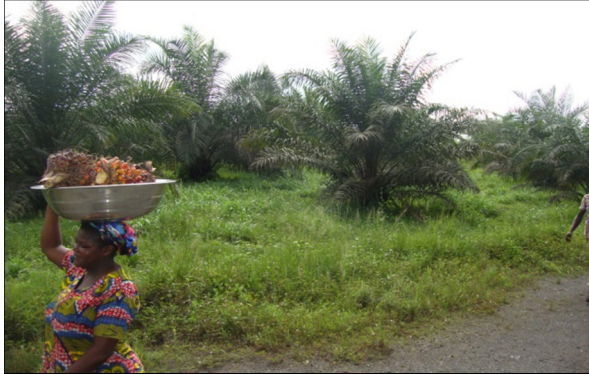
*Plate 16: Shows current state of the palm trees*

The concurrent reclamation/rehabilitation of the Hill B waste dump was continued steadily for the year under review. In 2013, daily agronomic practices mostly slashing in the plantation, weeding around the palm trees and application of NPK (15:15:15) fertilizer were done, pruning dead branches to improve aeration were carried out in the plantation to promote healthy growth and high yield. See plates 16 and 17 showing current state of the palm trees and first fruits harvested.

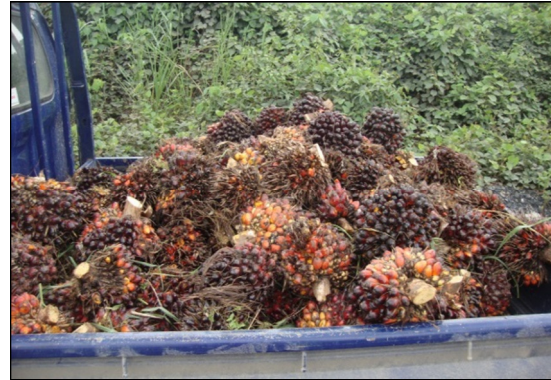
*Plate 17: Shows first fruits harvested*

First batch of the oil palm fruit has been harvested and sample of the fruit was sent to the Crop Research Institute for needed test and analysis to be carried. Harvesting of palm fruit started on large scale at the latter part of the year. Pruning of lower palm branches at the Hill B plantation continued; this is to improve aeration and bigger fruit bunch formation.

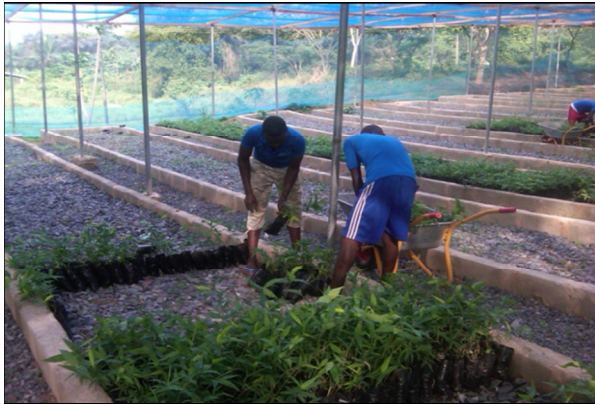
*Plate 18: Workers grading saplings*

India and Ethiopia. A mechanized borehole was also constructed to supply water at the nursery. See plates 18 and 19 showing workers grading saplings and view of the nursery.

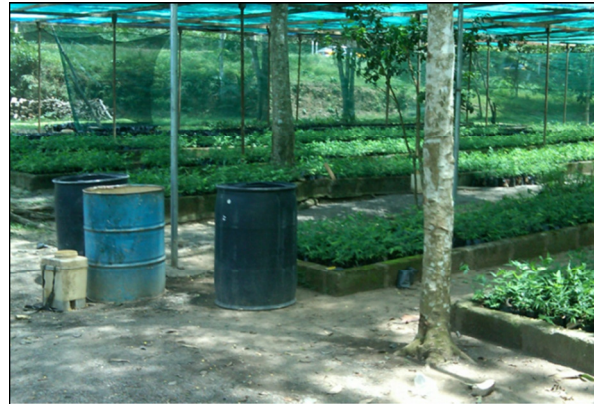
*Plate 19: shows View of the Nursery*

Following several researches in Ghana and India, in order to achieve successful cultivation of bamboo energy crops in Ghana, Darlow Ghana Limited signed a memorandum of understanding to partner with Ghana Manganese Company (GMC) in 2013 for a trial bamboo plantation. GMC's existing nursery was upgraded and significantly expanded to the standards required for the project to include infrastructure for vermiculture, manure, sand, soil mix, storage, propagules, potting areas and constructed nursery beds to manage 20,000 imported bamboo saplings from

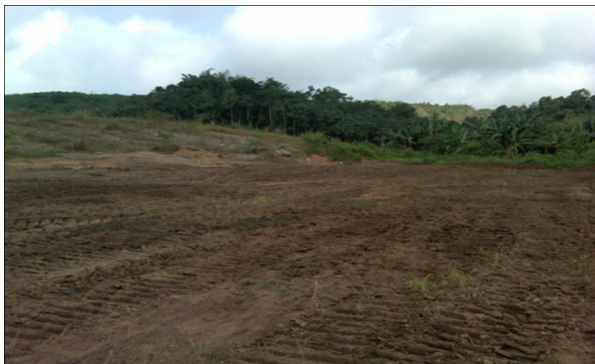
*Plate 20: shows showing trial plot cleared*

In order to commence the trial plantation, an area of 10 hectares was designated by GMC to Darlow Gh Ltd. The trial site is accessible by mine haul road and has direct access to water. Since the trial site was occupied by local farmers, compensation of 45,000 Ghana Cedi was paid to the farmers for crops affected by the project. Hired dozer and tractor were used in preparing the land and creating ridges in rows 2.5m apart for transplanting of the bamboo seedlings.

Drainage channels were created on the field to divert runoff so as to prevent any incident of water logging. See plates 20 and 21 showing trial plot cleared and tractor ploughing.

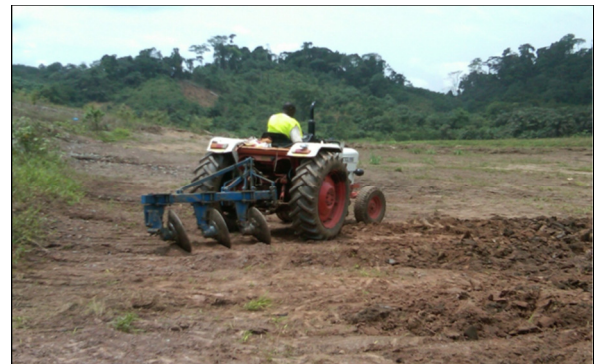
*Plate 21: show hired tractor ploughing*

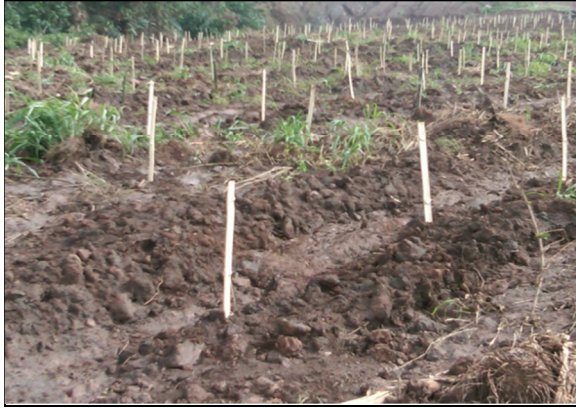
*Plate 22 show planting pegs*

The beema bamboo seedlings were transported from the nursery to the trial site for planting. Holes diameter and depth were 28cm, 24cm respectively. 150bags of compost fertilizer were applied to trial site. See plate 22 and 23 showing planting pegs and rainfall at the trial site.

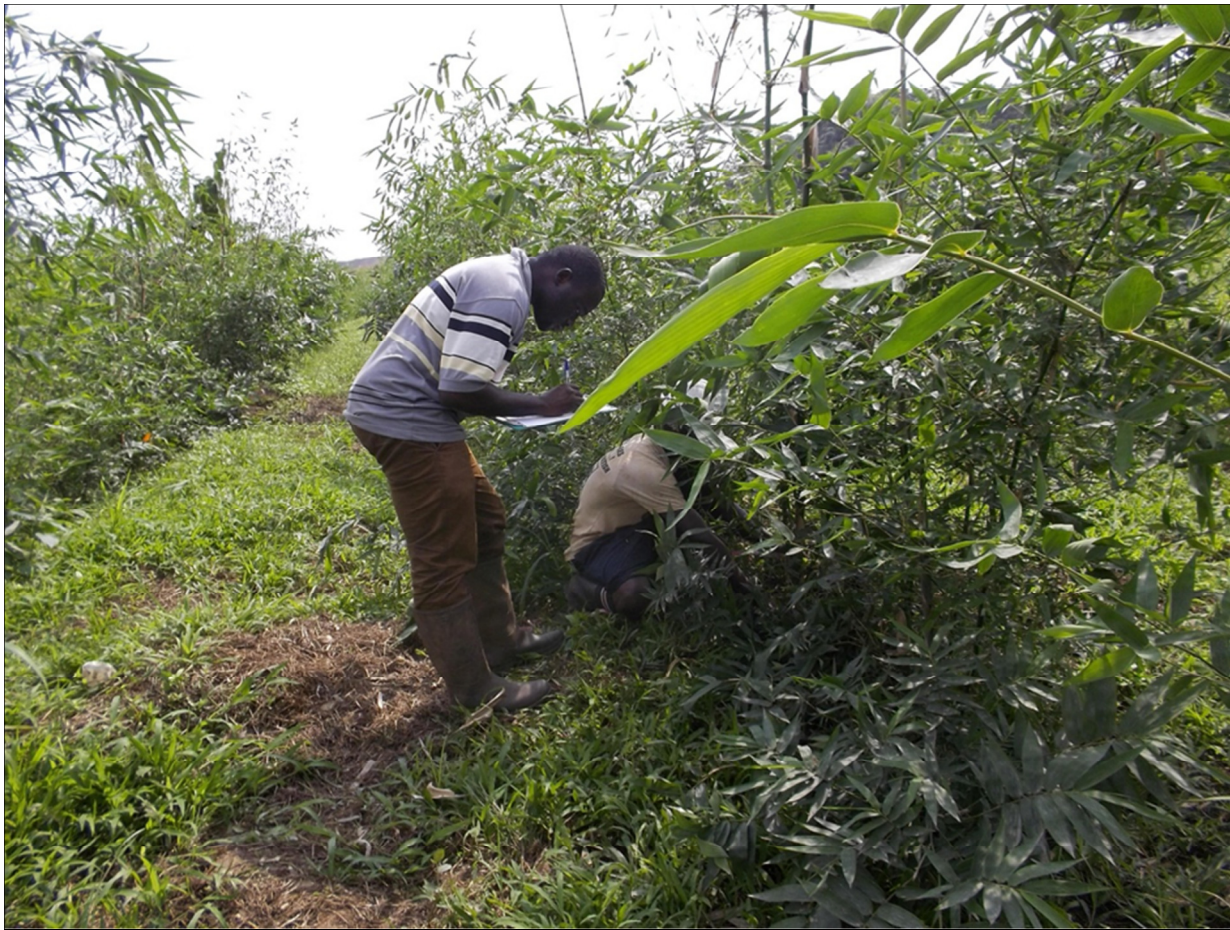
*Plate 24: shows the current status of the trial bamboo project*

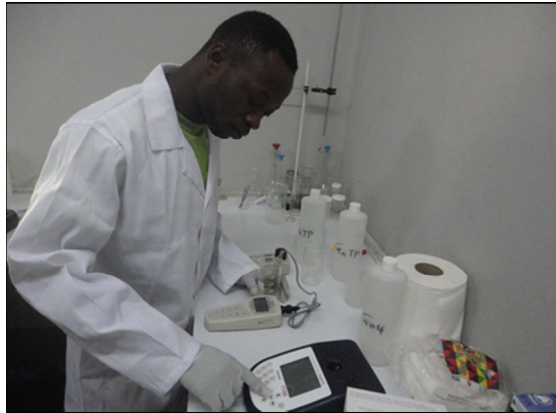
*Plate 47: Laboratory technician*

Drinking water is also analyzed for microbiological parameters such as total coli-form, faecal coliform, E-coli, Yeast and Mold. Four samples of water were taken daily to determine quality of

the presence of some water constituent. The parameters analyzed under investigation were mainly physiochemical parameters. See plates 47 and 48 showing Laboratory technician analyzing water quality.

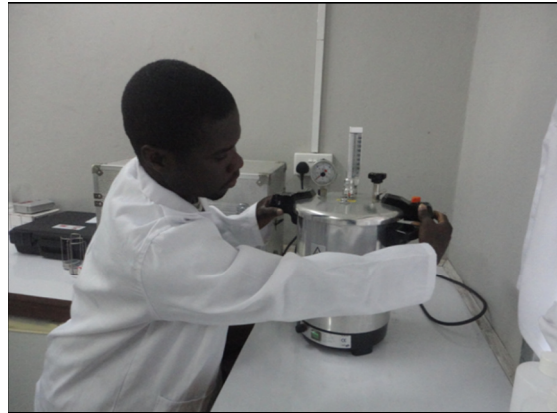
*Plate 48: Technician analyzing water quality*

A conductivity meter was used to measure the specific conductance, and total dissolved solid (TDS). Chlorine and pH were analyzed qualitatively using Brometymol and O-T iodine as reagents respectively. Lovibond 1000 comparator was used to carry out the qualitative analysis. The water samples were taken from two different places namely Gallaway and Golf course. The Gallaway pump station supplies portable water to the Nsuta community and the company's operational areas whiles the Golf course pump station supplies water to the bungalows.
