## **5.0 HEALTH AND SAFETY PERFORMANCE IN THE YEAR 2014**

### 5.2.5 Fire Incident Report on Bungalow 16

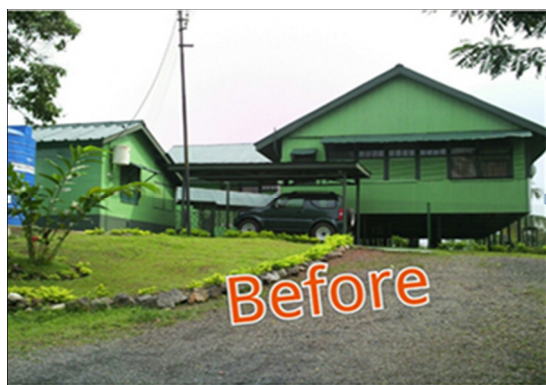
*Plate 26: Shows Bungalow prior to fire disaster*

At about 7:52pm on Friday 24th January 2014, a fire broke out at bungalow 16 which was formerly occupied by the Deputy Managing Director. Immediately, the Ghana National Fire Service (GNFS) as well as GMC Emergency Response Team (ERT) were summoned to control the fire from escalating and spreading onto nearby premises and vegetation. The fire spread so quickly that it engulfed the whole building before the arrival of the GNFS. It was finally extinguished after battling for about five (5) hours. Close-by residences were evacuated and no fatality and injuries were recorded since the bungalow was unoccupied at the time of the incident. See plates 26 and 27 for the bungalow before and after the fire outbreak respectively.

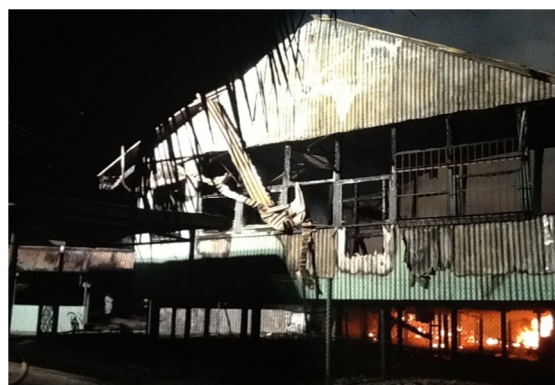
*Plate 27: Shows Bungalow after the disaster*

- c. Lightning arrestor fitted to the building was damaged by the fire;
- d. It was revealed that the security guard on duty at bungalow 16 was not aware of the fire out-break as he was taking refuge under the building due to the rainstorm and only responded to security control communication at the time of the fire;

- k. The service cables/pole and all household items were found burnt by the fire;
- l. It was found that evacuation and traffic management worked efficiently.

All evidences point to support that harsh meteorological condition (lightning induction) over bungalow 16 caused the fire. Conditions were observed locally at the time of the fire. The following evidences confirm the likelihood of the source of ignition by lightning induction:

The harsh meteorological conditions at the time of the fire, the available fuels (wooden structure and LPG gas), and the topography of the surrounding area, all contributed to the fire event. Generally, there are two possible hazards posed by lightning in terms of fire; these are direct lightning hit and induction. Strong induction is capable of destroying electronics in a way that serves as a source of ignition.

Upon systematic fire scene examination, the investigators eliminated the presence of external heat sources. Further verifications from witnesses interviewed and observations, the investigators identified one potential heat source (fire ignition) within the area to be lightning induction fueled by LPG gas located in the kitchen.

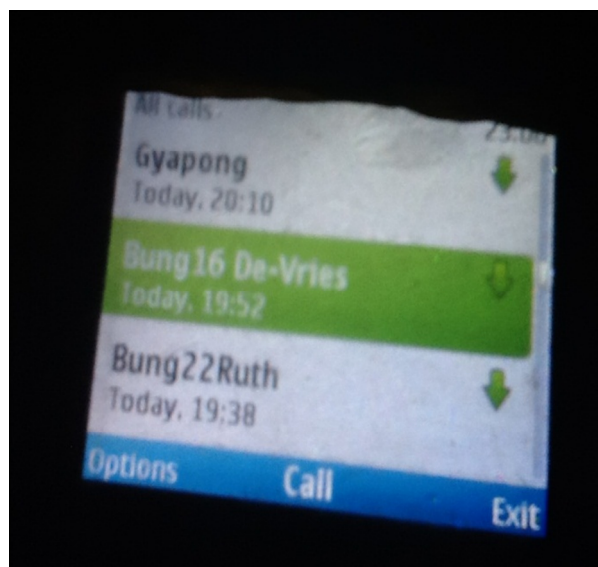
Plate 28: Shows Fire alarm System notification

An eye-witness saw lightning striking the bungalow and heard the Automatic Alarm System Siren blowing, another witness saw lightning and smoke from the building and called ERT member. Automatic Systems notified about a fire alarm. See plates 28 and 29 for fire alarm system notification and MTN call made to ERT member.

- b. Alarm System fitted to the house to alert ERT/Security of fire hazards and intruder presence notified the fire outbreak earlier than any other report to the ERT;

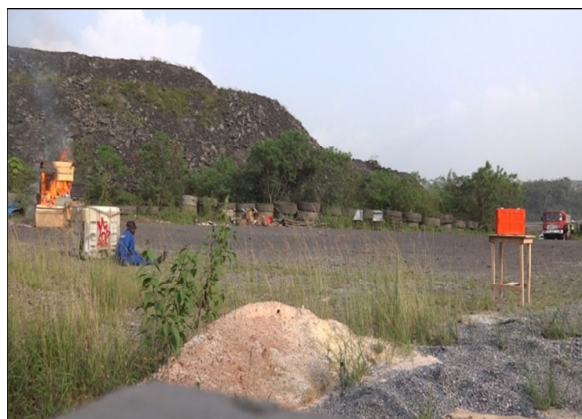
*Plate 30: Shows fire drill scenario setup at the scrap yard*      *Plate 31: Shows ERT extinguishing fire*

A scenario was created as follows: A Security guard's house located at scrap yard containing empty cartons caught fire. A petrol tank was near to the incident scene and an employee who saw the fire escalating to the petrol tank and an adjacent laboratory got a severe burn on the right arm and fell when he attempted to initially put out the fire. The main boom to the scrap yard was locked with a padlock to serve as obstacle to the Emergency Response Team.

It was noted that, personnel of ERT were inadequate in case of emergency and needs to be increased. G4 Security Supervisors and Crew should be sensitized to practically involve themselves in assisting ERT in emergencies; even serve as by-standers to direct unauthorized personnel and vehicles during such situations. See plates 30 and 31 below for firefighting demonstrations.

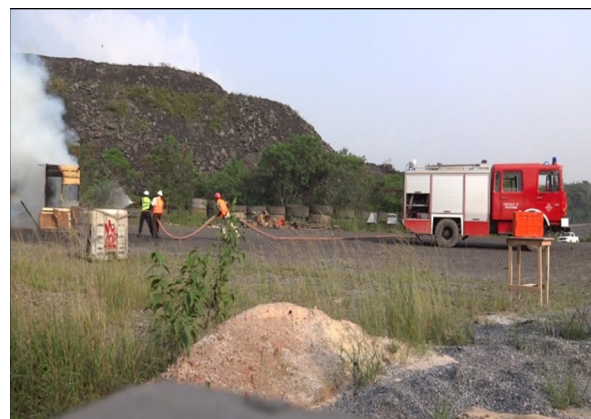
The emergency response team spotted the casualty in pains and carried him to a safe location and the fire tender was operated to extinguish the fire. Response time by ERT was excellent, identification of a casualty at the scene and immediately carried from danger to safe place was good. Operating the fire tender to extinguish fire was also perfect.
