EXECUTIVE SUMMARY

The **Communication on Progress** (COP) Report is a report on the activities of the mine during the year 2015. The report will highlights mining operations, processing plant, fuel, energy, water management and Corporate Social Responsibility (CSR) of the Ghana Manganese Company Limited.

1.0 INTRODUCTION

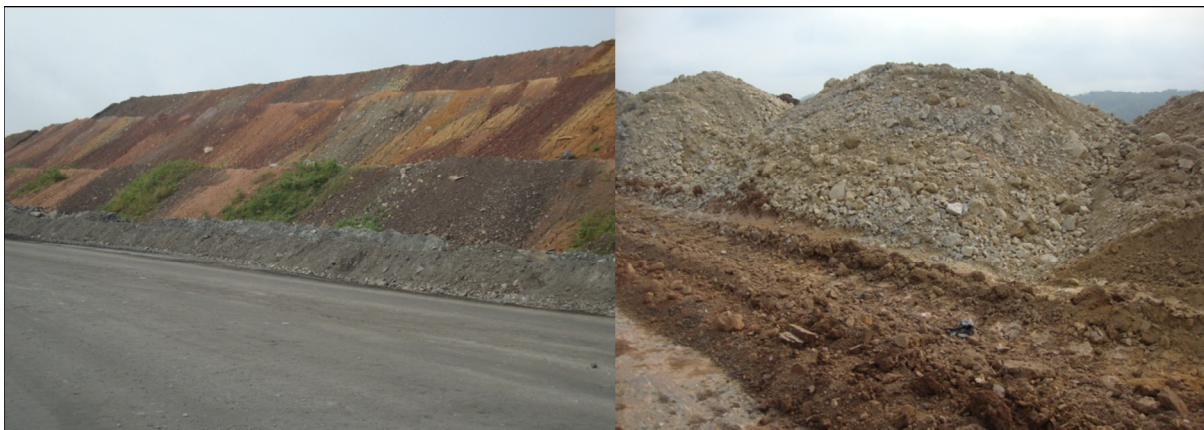
Plates 3 and 4: Show topsoil and subsoil management on the mine

During the year under review, sub-soils totaling 21,111 metric tonnes were generated from development of Pit C Central West (9,115), Central East (8,189) and South West (3,807) and stockpiled at the Hill B soft dump for future closure reclamation/rehabilitation works.

To control erosion of the stockpile, calopogonium seeds (leguminous cover crop) were broadcasted on its slopes. Regular inspections at the mine face were conducted to ensure that benches, berms and waste dump parameters complied with the Minerals and Mining (Health, Safety And Technical) Regulations, 2012 (LI 2182) and EPA Akoben Criteria during the year under review. Plates 3 and 4 below show topsoil and sub-soil management on the mine.

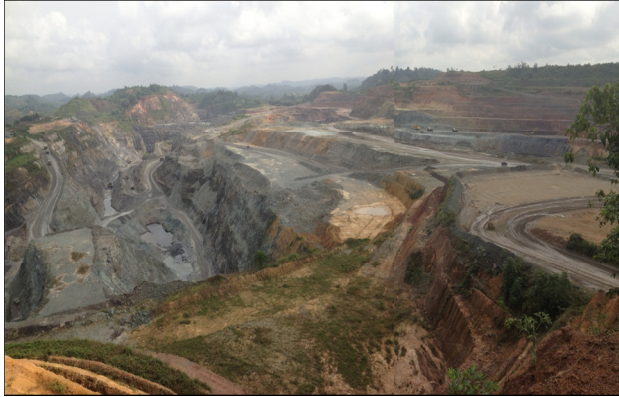
Plate 5: Shows Pit C Development in 2014

The LOM pit shell was extended to enable maximum extraction of the ore body. The areas which fell within the pit shell needed to be developed to open up so as to achieve the aims of the extended life of the mine. The pit was re-designed as per what standard bench heights and slope to reach the ultimate pit bottom. See Plates 5 and 6, Pit C Development in 2014 and stage of Pit C in 2015.

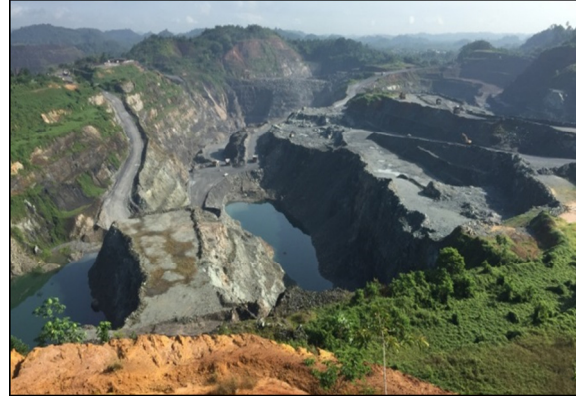
Plate 6: Shows stage of Pit C in 2015

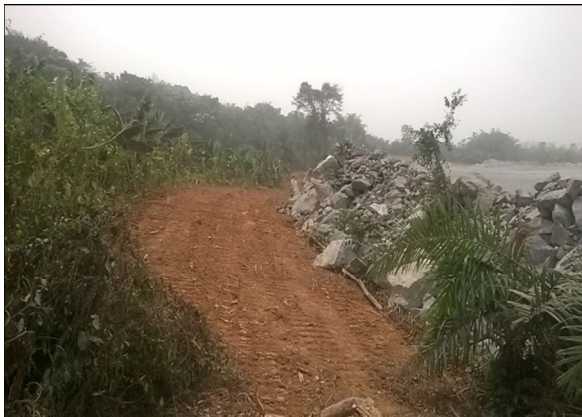
Plate 7: Shows Waste Dump development

As part of GMC's development schedule to increase the dumping space, topsoil striping activities were carried out on the adjoining hills to the ballast (hard) waste dump. See plates 7 and 8 for waste dump developments.

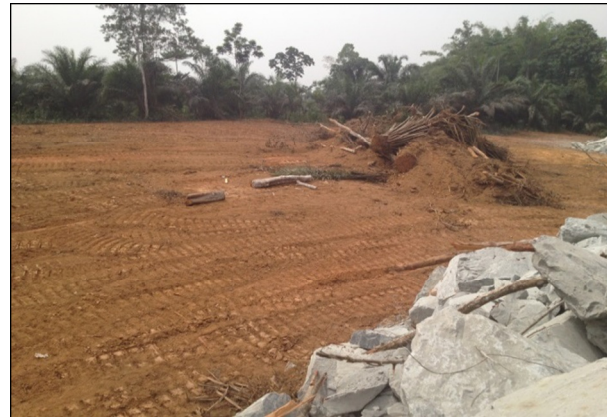
Plate 8: Shows Waste Dump development

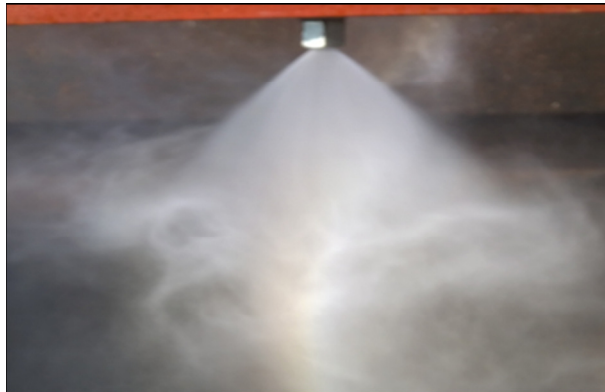
Plate 9: Shows High-Pressure nozzles for fog making

New dust suppression systems were installed at the bottom section of the carbonate plant and the CPE respectively. Further, the old damaged steel tank structure was replaced with a modern HDPE tanks which do not contribute to pump damage by iron residuals anymore. New water Poly-tanks for primary dust suppression system were also installed. Investments were made in booster pumps, High-Pressure pumps, nozzles and piping. See Plates 9 and 10 showing High-Pressure nozzles for fog making and High-Pressure booster pumps respectively.

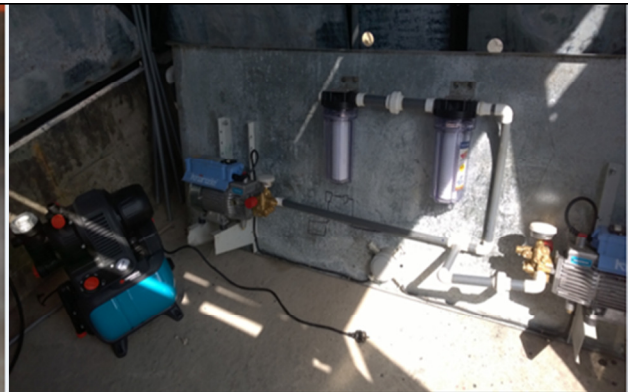
Plate 10: Shows High-Pressure booster pumps

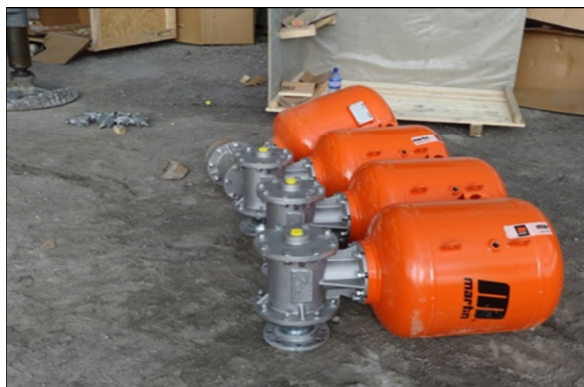
Plate 11: Shows Air cannons delivery to store

They are permanently installed on bins, silos, hoppers and used for prevention of chocks and caked materials in chutes; the operating pressure in the range of 5 – 10 bar. The compressed air

contained in the pressure vessel instantly releases, and the achieved blast, called the impact force, evacuates the material sticking to the walls.

The air releases (firing) using an automatic sequencer. The importance of these air cannons is to eliminate or reduce downtime operation on manually clearing of chokes or caked materials in chutes. See Plates 11 and 12, Air cannons delivery to store and Installed Air cannons for clearing chokes and clogging at secondary section (fines chutes).

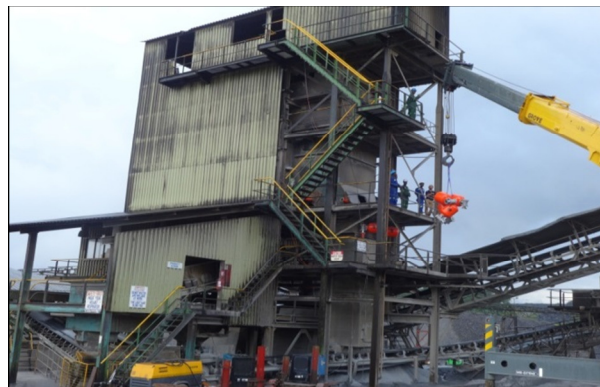
Plate 12: Shows Installed Air cannons for clearing chokes and clogging at secondary section (fines chutes)

An air cannon or blaster is a de-clogging device composed of two (2) main elements.

- A pressure vessel (storing air pressure)
- A triggering mechanism

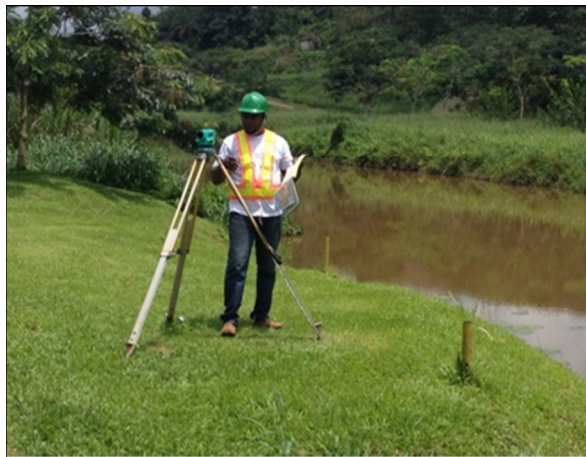
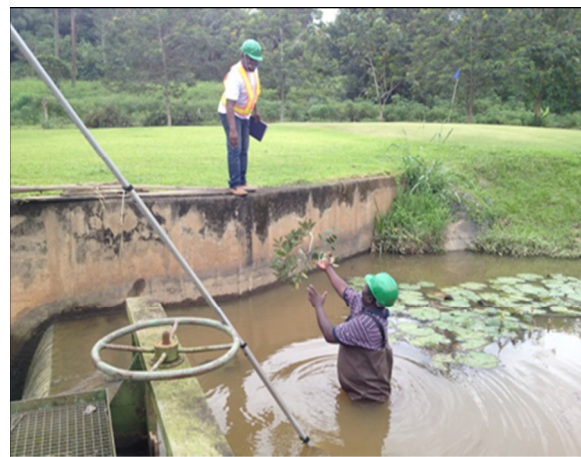
Plates 15 and 16 present Staff of MacWES installing the staff gauges

As part of the recommendations of the Water Resources Commission, a water flow meter, water level indicator and a diver was installed on the Kawere stream to determine the volume of water passing through GMC concession annually. Results obtained from the instruments will be submitted to the Water Resources Commission (WRC) and also recorded for GMC Water Balance and the hydrological assessment.

A gauging site was selected in the stream for the purpose of measuring discharge in the stream continuously known as either stream gauging station or a hydrometric station. Stream flow is expressed in dimensions of cubic meters per second (m^3/s). A pressure transducer diver data logger system was installed for continuous recording of water levels. The system consists of a submersible diver which continuously records a column of water pressure above it at a predefined interval. Plates 15 and 16 present Staff of MacWES installing the staff gauges.

Hydrologic monitoring stations (gauging stations) were placed at locations where the river channel was stable so that the river's cross-section did not change significantly over time. Water

level readings were taken continuously, and at times on a periodic basis as often as hourly in some cases, but daily and sometimes even less often using visual inspection of a gauge plate or staff gauge, paper chart on a chart recorder or digitally with a data logger. To relate water levels to flow, a rating curve was developed to allow one to estimate discharge based on water level. In order to create the rating curve, the flow for a variety of water level conditions was calculated.

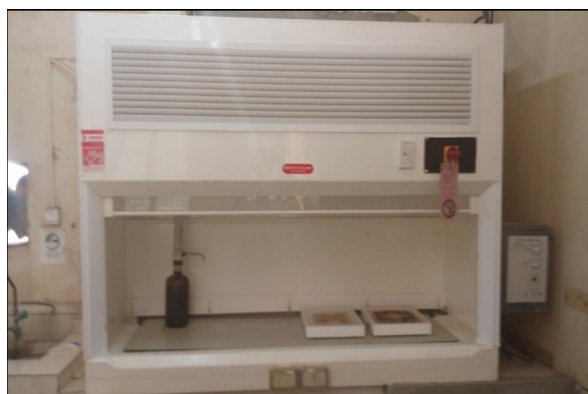
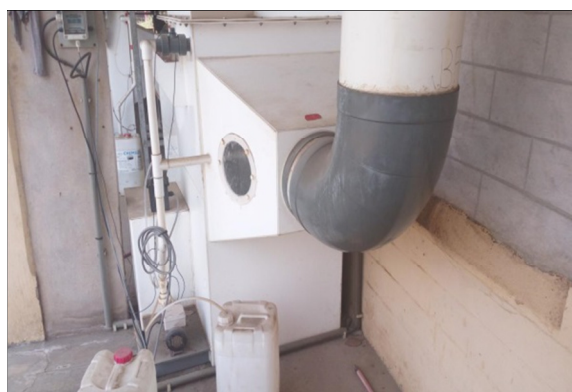
Plates 17 and 18: Show pictures of the new fume-hood installed at the Assay Laboratory/Department

The Assay Laboratory installed a new JohnDec Fume-hood Scrubber as a replacement of the old existing fume-hood in November 2015.

The JohnDec Fume hoods are designed to provide personnel protection from toxic or volatile chemicals by continuously delivering airflow away from the user to the work area. Air is then filtered and/or treated by the building's exhaust system before exiting the facility. It consists of a cabinet, operating bench top, baffle-wall, back and top panels, safety glass window with balance weight that is movable up and down, lighting, pH monitor (that monitors the pH of solutions leaving the working area to the environment) and ducts fixed high up into the sky (that releases water vapour into the atmosphere).

During its operations a concentrated sodium hydroxide is also introduced to neutralize the acid produced during the digestion process. It was designed for occupational safety and ergonomics and for long term use. Plates 17 and 18 are pictures of the new fume-hood installed at the Assay Laboratory/Department.

- The fume chamber clears/reduces the harmful gas produced in the analysis;
- Protects the health of laboratory personnel from inhaling toxic gases;
- Ensures high-level safety and superior operability;
- Protects the environment from acidic and basic wastes that would have ended up in the ecosystem;
- Improves the sanitary condition of working and operating efficiency.

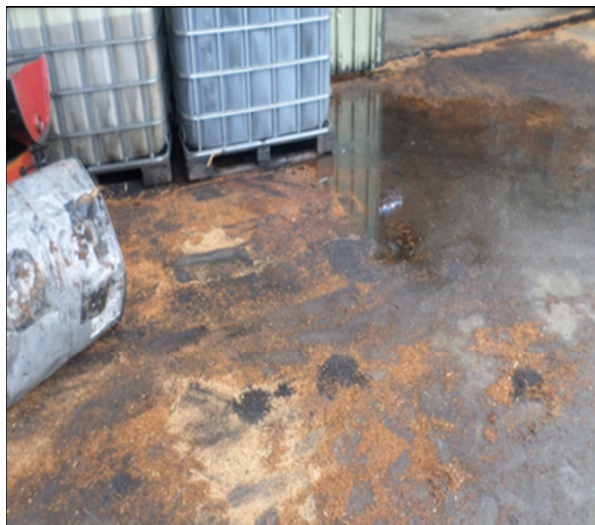
Plate 21: Shows IBC storage tanks in front of CAT Machine shop

On 26th October, 2015 at about 8:05am the workshop was inspected as part of the daily environmental inspections. On reaching the CAT oil storage area, it was noticed that sawdust had been spread all over the entrance and behind the oil drums. See Plates 21 and 22, IBC storage tanks and dirty oil drums in front of the CAT Machine shop respectively.

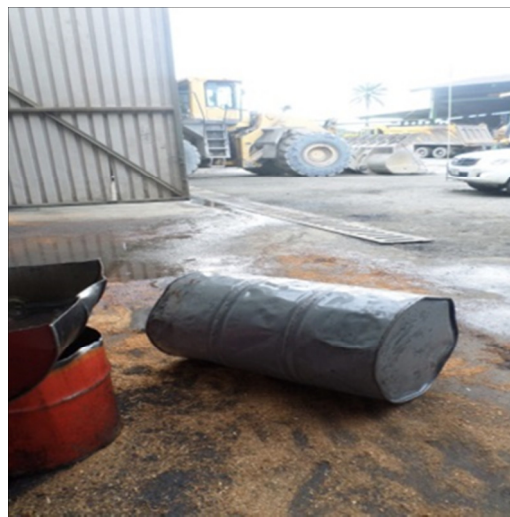
Plate 22: Shows dirty oil drums in front of CAT Machine shop

Investigations revealed that a drum containing waste oil was left opened with a funnel on it after work and heavy downpour (65mm) on that day went straight into the drum resulting in the leak of the waste oil from the drum to the drainage system. The spilled oil moved through the gutter in front of the EME/Light Duty workshop, through the culvert across the road into the oil/water separator and was contained in the oil/water separator demonstrating the efficiency of the oil/water separator. See Plates 23 and 24 showing drainage leading to the oil/water separator and scoping and cleaning the oil from the drains.

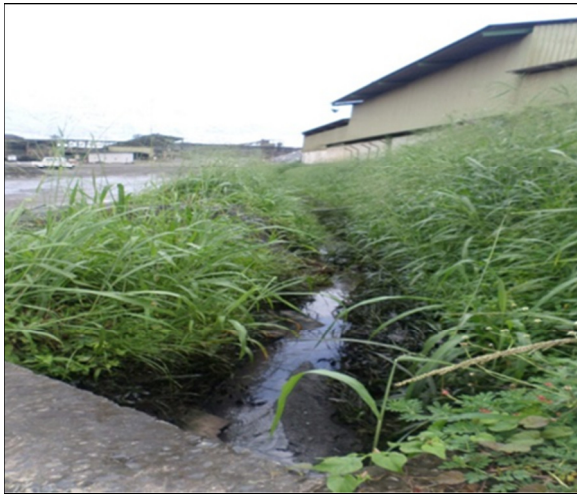
Plate 23: Shows Drain leading to the oil/water separator

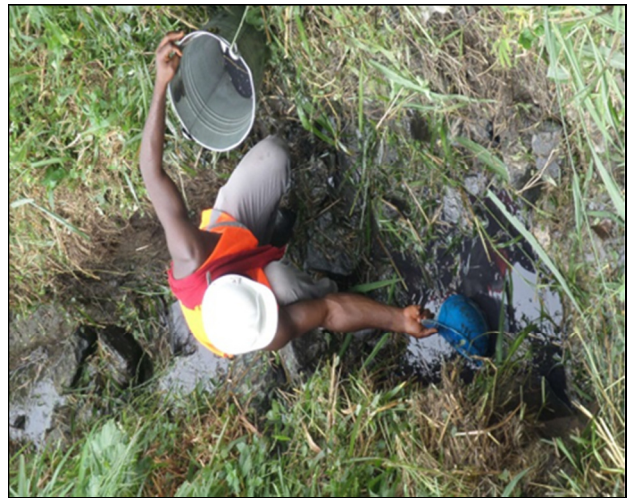
Plate 24: Shows scoping and cleaning the oil from the drains

However, the Environmental and HD/EME Departments responded quickly to the incident by scoping and cleaning the oil from the drains and the oil/water separator, thus, preventing the oil to enter into the external environment. See Plates 25 and 26, cleaning works at the workshop and meeting with the maintenance workshop employees respectively.
