Chihuahua Operations

Performance Review

BWIGroup Suspension Systems QRD Review

Presented 5/28/2019 GART Data through 4/30/2019

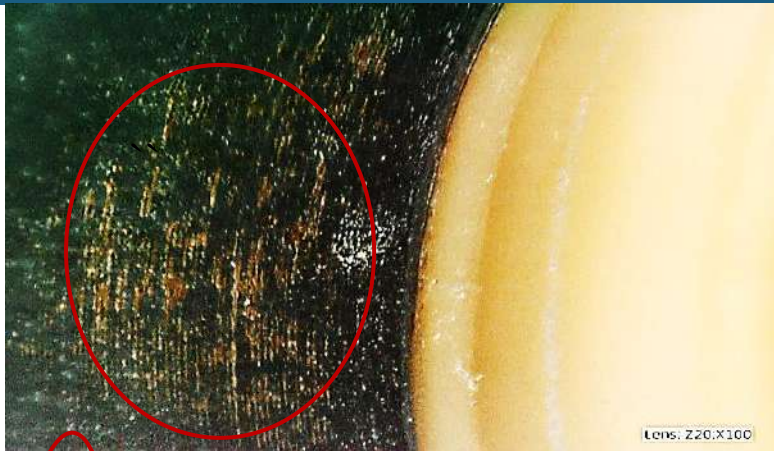
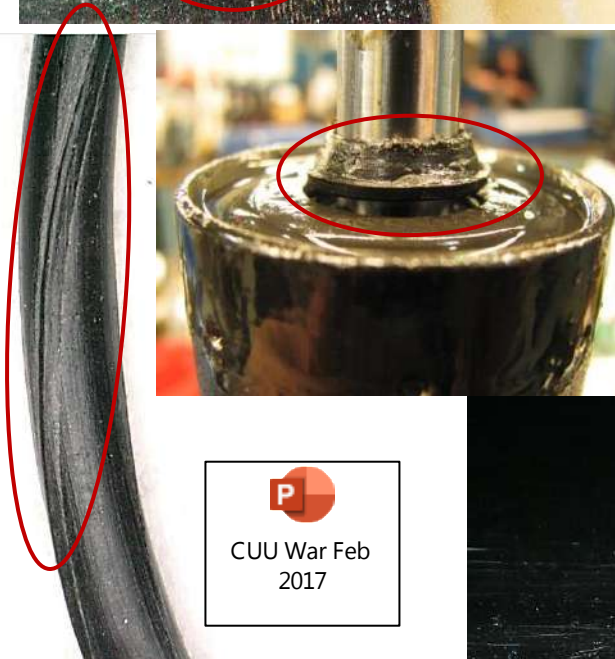
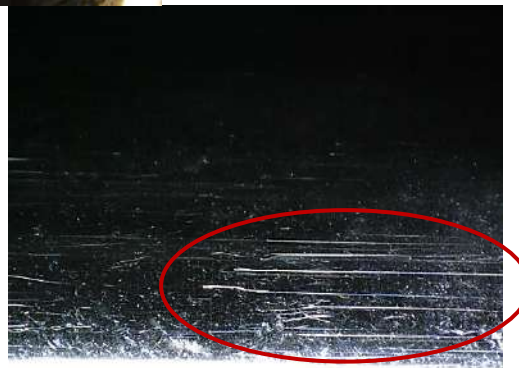
CUU War Feb
2017

- Damper build date: 8/17/2016
- Model: 2017 XTS Rear
- VIN: 2G61M5S34H9112575
- Mileage: 43,186
- State: CA
- Cause: Leakage

- Leakage on cover assembly
- Wiper seal dislodged from cover assembly

- Resistance: 1.23 - **OK**
 - Spec: 1.28 ± 0.2 Ohms
- Preload: 213 - **NG**
 - Spec: 432 ± 40 N
- Stickout: 83 - **NG**
 - Spec: 33.0 ± 3.0 mm
- Piston rod surface finish measurement:
 - Spec: .04 Ra Max
 - Measured: .0175 to .0481 Ra **NG**

- Deep scratches and comets on rod **NG**
- Twisted O-Ring **NG**
- Rust in bearing

- Twisted O-Ring allowed for gas and fluid leakage to occur.
- Dislodged wiper seal allowed for contamination on the rod, scratching it when stroking.

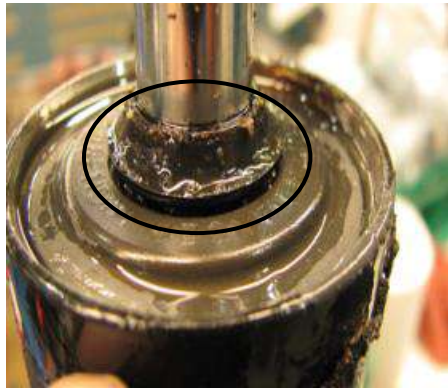
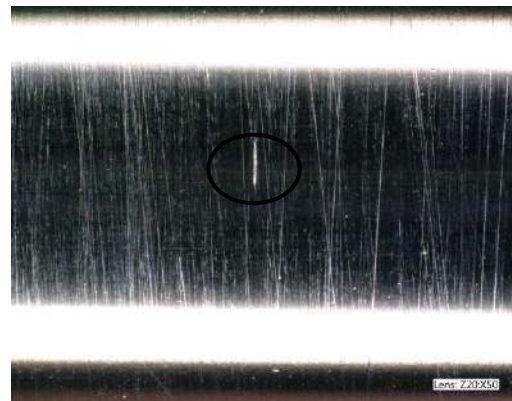
- Resistance: 1.26 - **OK**
 - Spec: 1.28 ± 0.2 Ohms
- Preload: 272 - **NG**
 - Spec: 432 ± 40 N
- Stickout: 53 - **NG**
 - Spec: 33.0 ± 3.0 mm
- Piston rod surface finish measurement: **NG**
 - Spec: 0.040 Ra Max
 - Measured: .0227 to .0444 Ra **NG**

- Scratches and some comets on rod **NG**
- Rust accumulation on bearing and damaged primary seal
- Rod surface finish does not meet spec **NG**

- Dislodged wiper seal allowed for contamination to come in contact with the rod, scratching and damaging the rod. The damaged rod compromised the seal and allowed fluid and gas leakage

- Gen 2.5 Rod guide assembly put into production 1/12/2018
- Implemented 100 grit rough grind wheel, and improved machining parameters 3/23/2018

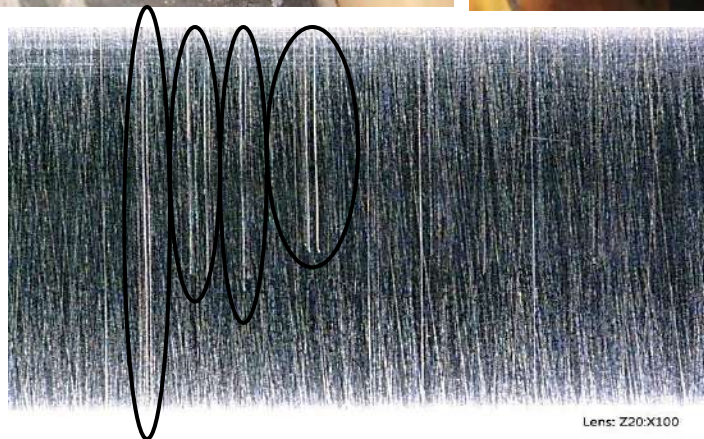
- Resistance: 1.26 - **OK**
 - Spec: 1.28 ± 0.2 Ohms
- Preload: 249 - **NG**
 - Spec: 432 ± 40 N
- Stickout: 62 - **NG**
 - Spec: 33.0 ± 3.0 mm
- Piston rod surface finish measurement: **NG**
 - Spec: 0.040 Ra Max
 - Measured: .0214 to .0537 Ra **NG**

- Deep scratches **NG**
- Rust accumulation on bearing
- Rod surface finish does not meet spec **NG**

- Dislodged wiper seal allowed for contamination to come in contact with the rod, scratching and damaging the rod. The damaged rod compromised the seal and allowed fluid and gas leakage

- Gen 2.5 Rod guide assembly put into production 1/12/2018
- Implemented 100 grit rough grind wheel, and improved machining parameters 3/23/2018

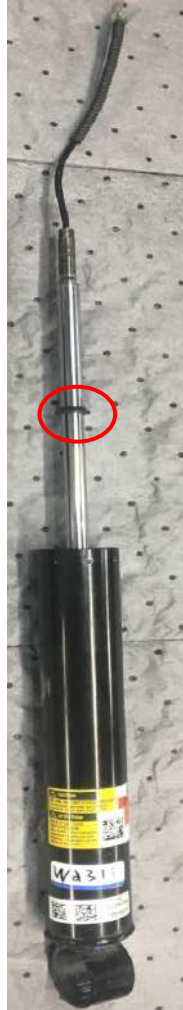
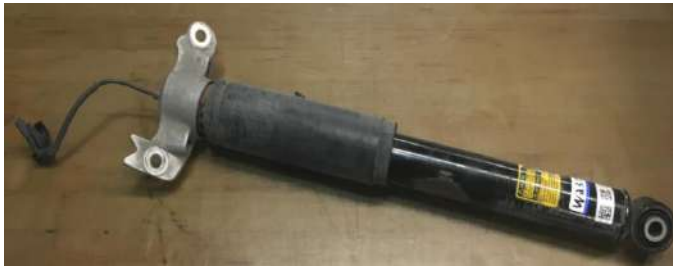
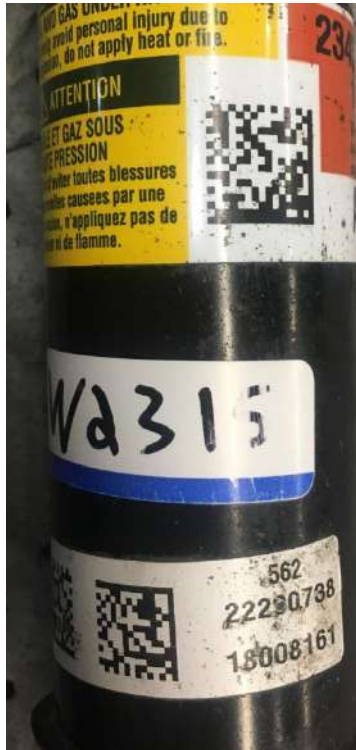
- Wiper seal dislodged from cover assembly
NG
- Wear on reservoir tube from dust shield
NG

- Deep scratches, “watermarks,” and comets on rod **NG**
- Some accumulated rust on bearing due to wiper seal allowing contamination into the bearing **NG**

- Wear on outside of reservoir tube indicates dust shield wearing on reservoir tube causing noise
- **Corrective Action:**
- Gen 2.5 Rod guide assembly put into production 1/12/2018
- Implemented 100 grit rough grind wheel, and improved machining parameters 3/23/2018
- **Dust shield rubbing corrective action TBD**
